## Site Description

A GPR survey of the Heritage Common area was undertaken. The survey method was effective in imaging subsurface infrastructure and any associated ground disturbance. The use of a shielded RADAR antennae was successful in rejecting responses from surface interference.

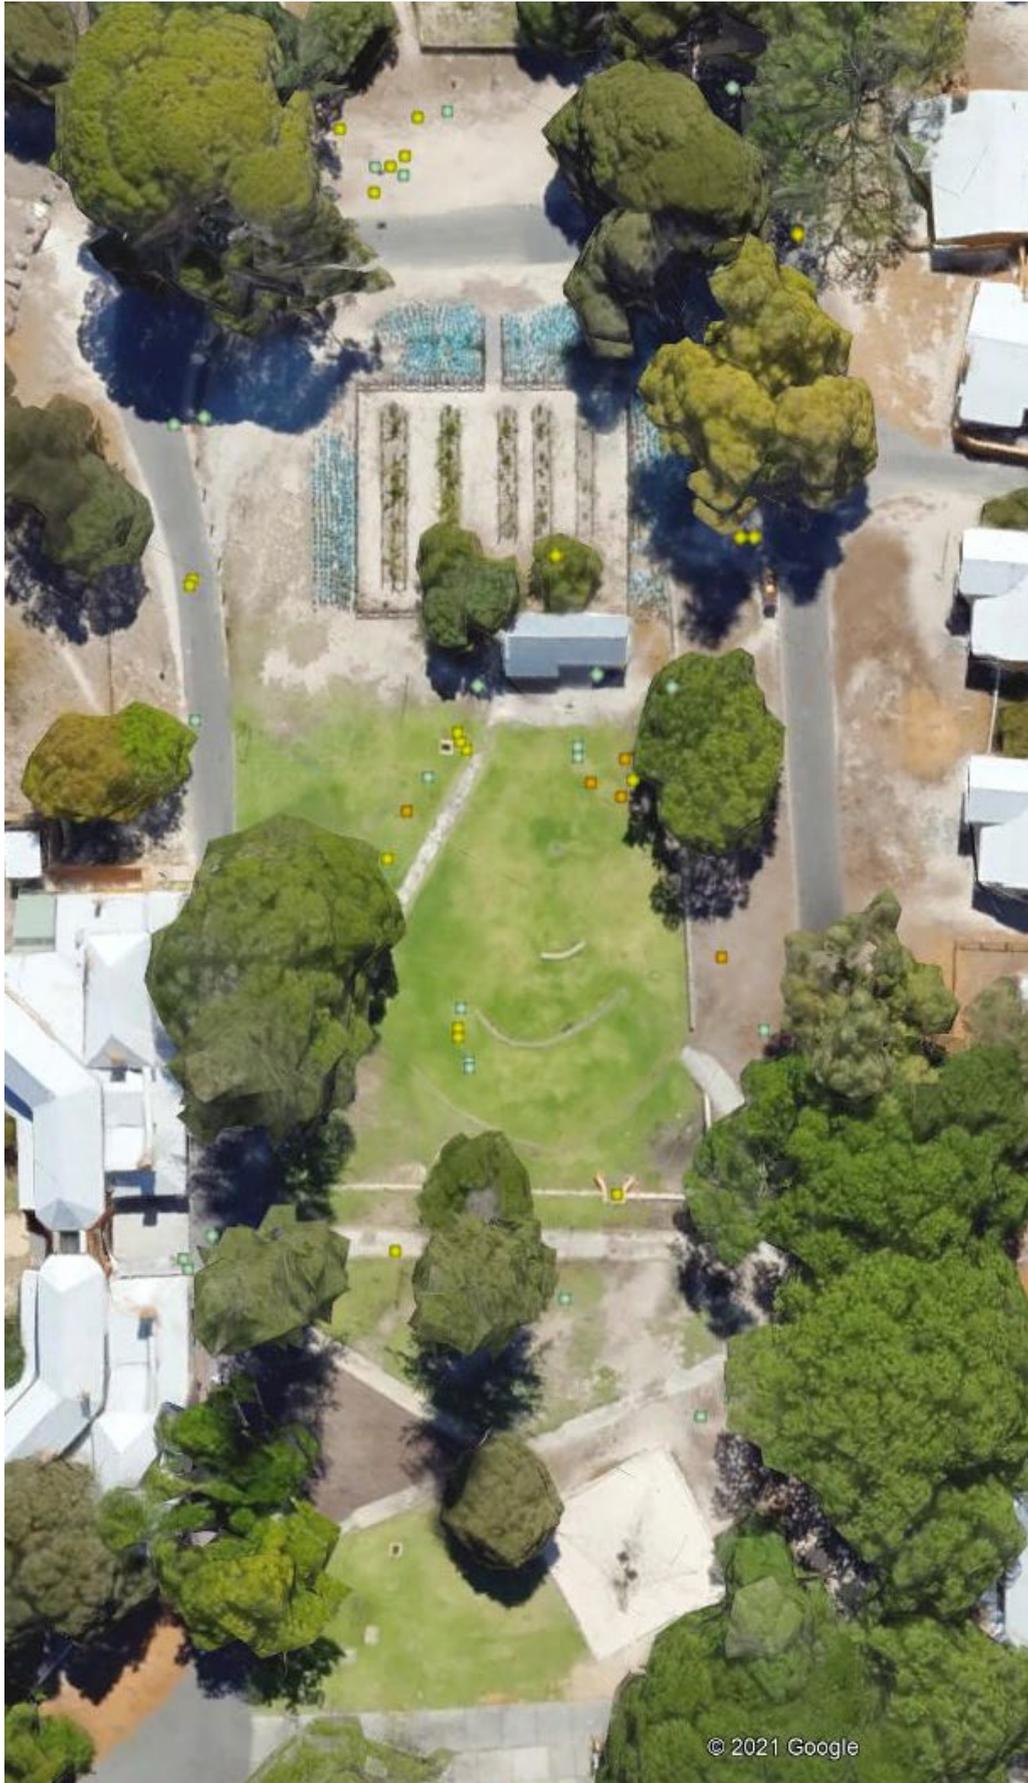
These anomalies are typically associated with the edges of paths, tree roots or occasionally as part of a larger anomaly such as deep drainage. *Figure 2* shows the shallow anomalies. There is a strong correlation with the edges of paths or roads and tree roots. The anomalies to the top of the image are part of the RADAR response to the large drainage feature in that area.

*Figure 2 Location of Shallow Anomalies 0 – 0.7m Deep*

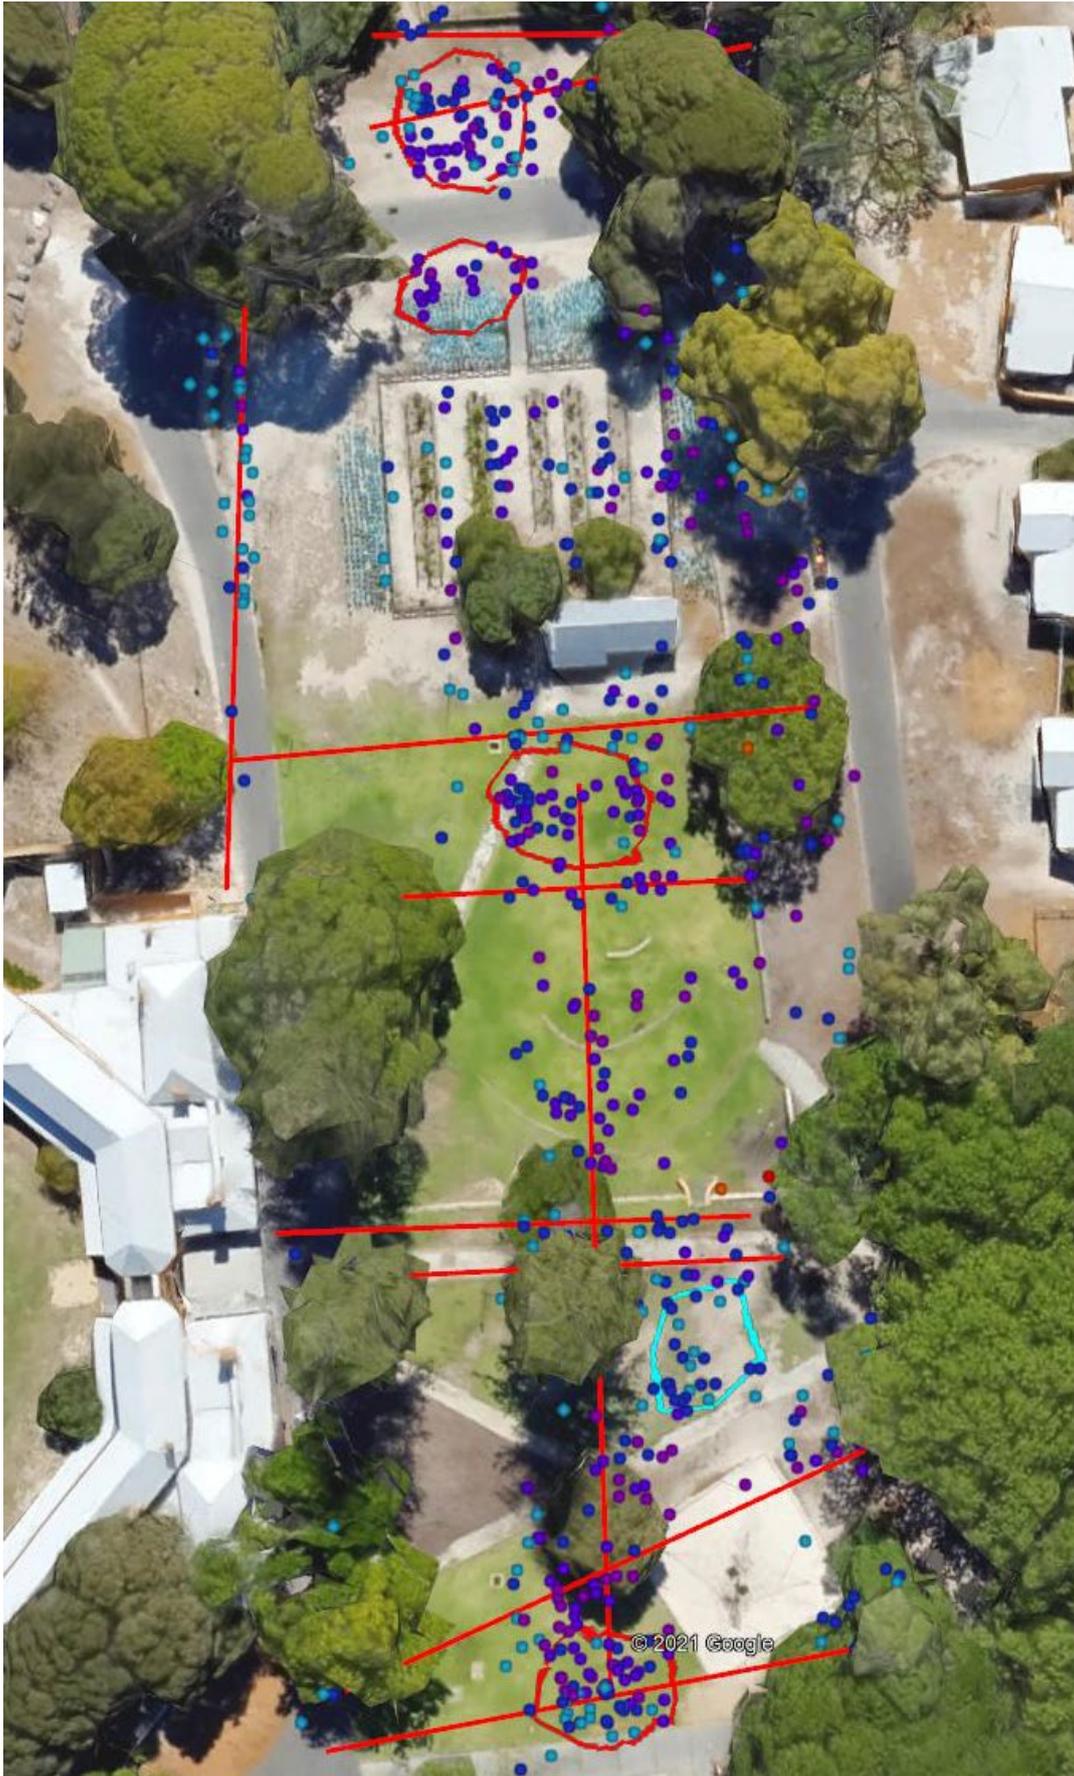
The majority of RADAR responses are in the 0.7m to 1.3m depth band. To interpret this band of depths, it is assumed that anomalies near trees, paths and retaining walls are caused by these same objects. As the RADAR pulse radiates in all directions, proximity to a retaining wall for example is plotted with depth on the radiogram. However the reality is that the RADAR energy is allowed to travel laterally and reflect from these objects. This gives the appearance of a deep anomaly in the data, where in fact it came from a near surface object. An example of this can be seen in the centre of figure 3 and the anomalies plotted around the semi circular retaining walls.

Linear features are present in the data and are interpreted by finding linear trends in the data. Notes taken during surveying about the locations of drain covers, utility covers etc aid the interpretation. The linear features are a combination of electrical and drainage lines.

The areas circled in red are interpreted as drainage related. The anomalies are consistent with soakwells, given the broad area of these anomalies, coupled with proximity to surface grates.

The large number of anomalies in the cottage garden and surrounding the cottage are thought to be due to existing infrastructure. A retaining wall and large trees account for the anomalies to the East of the cottage. The cottage garden shows multiple random scattered anomalies that are consistent with limestone rubble. Posts and fences associated with the garden would also contribute to these anomalies.

Figure 3 Location of Anomalies 70cm to 1.3m

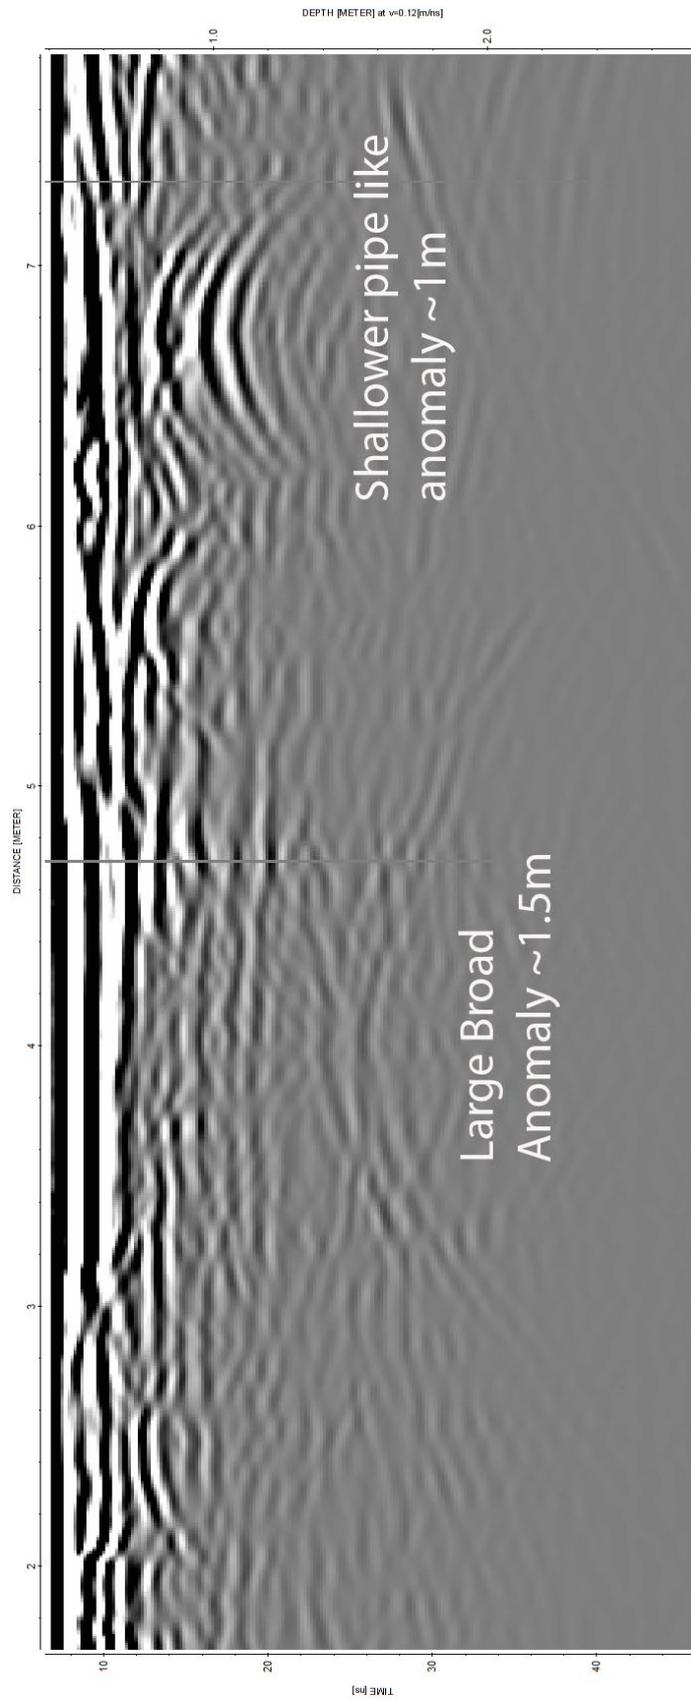
A group of anomalies circled in blue are not readily explained by infrastructure. They are positioned away from linear features and are away from the influence of tree roots. It is possible they are part of a soakwell system. *Figure 4* shows some data from this area. A large broad anomaly at the 4m mark is at 1.5m depth. Above the anomaly can be seen a break in the layering indicated a trench or large hole was dug. The size of the anomaly indicates a large structure such as soakwell. Smaller anomalies at 5.6m and 6.7m are consistent with pipes.

Figure 4 Line of Data Within Blue Circle

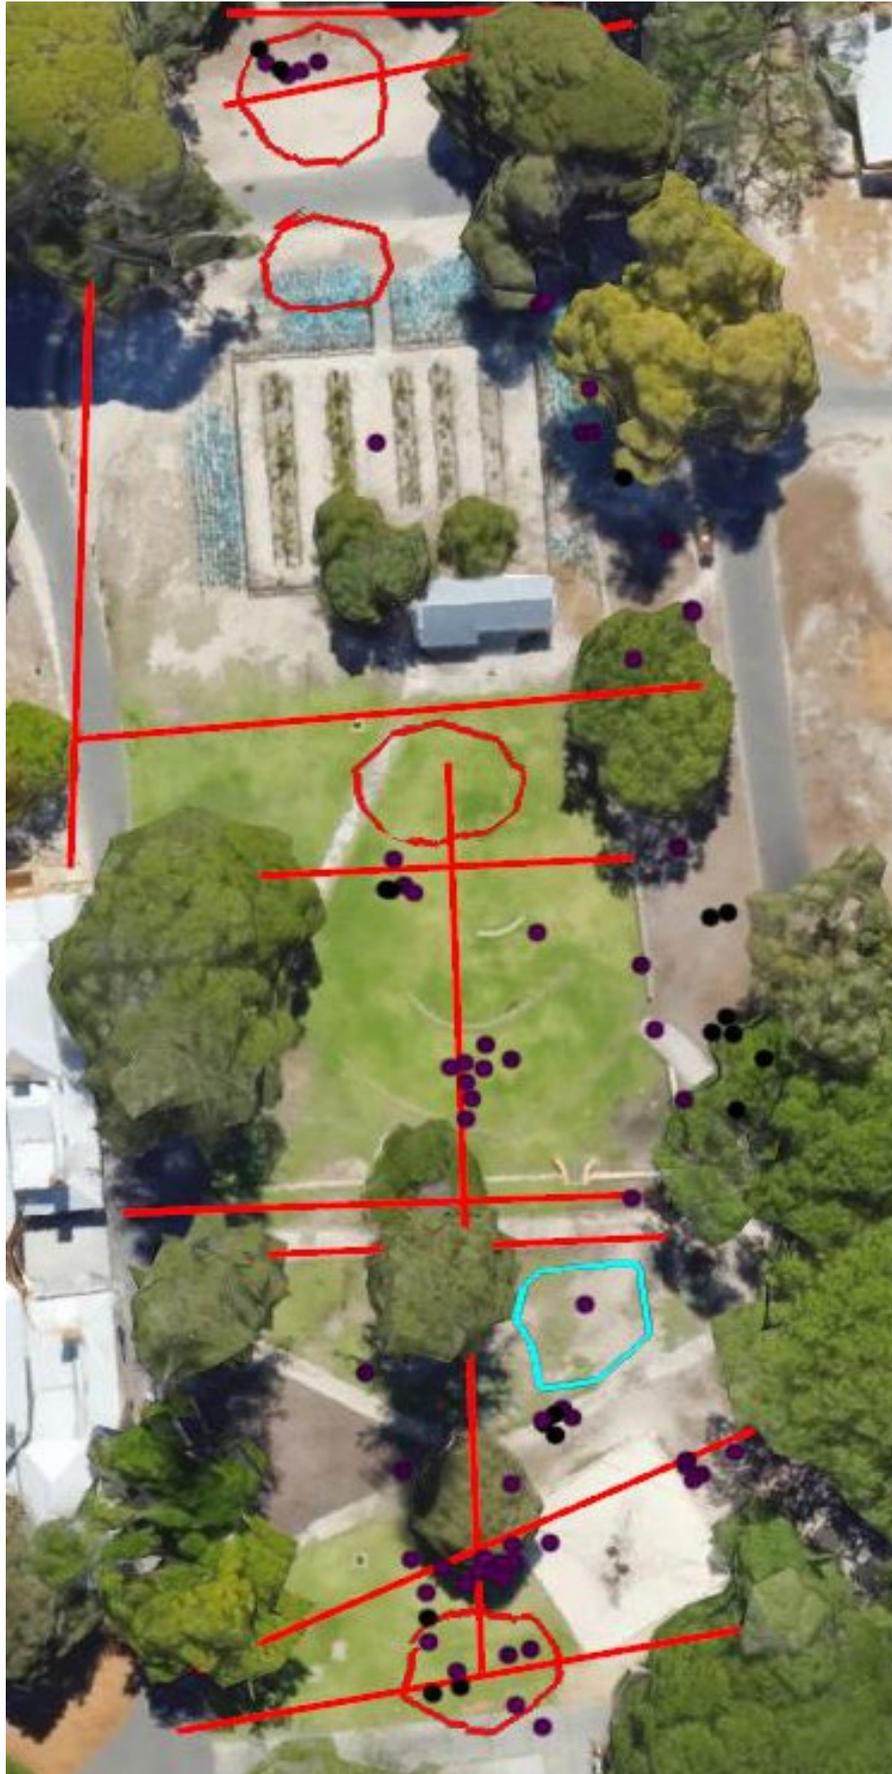
A small group of anomalies were detected beyond 1.3m as shown in *figure 5*. Most of these anomalies occur in or very close to interpreted structures. Anomalies to the East alongside the road are associated with the structure of the road and possibly the tree roots in this area.

Figure 5 Anomalies 1.4m to 1.8m

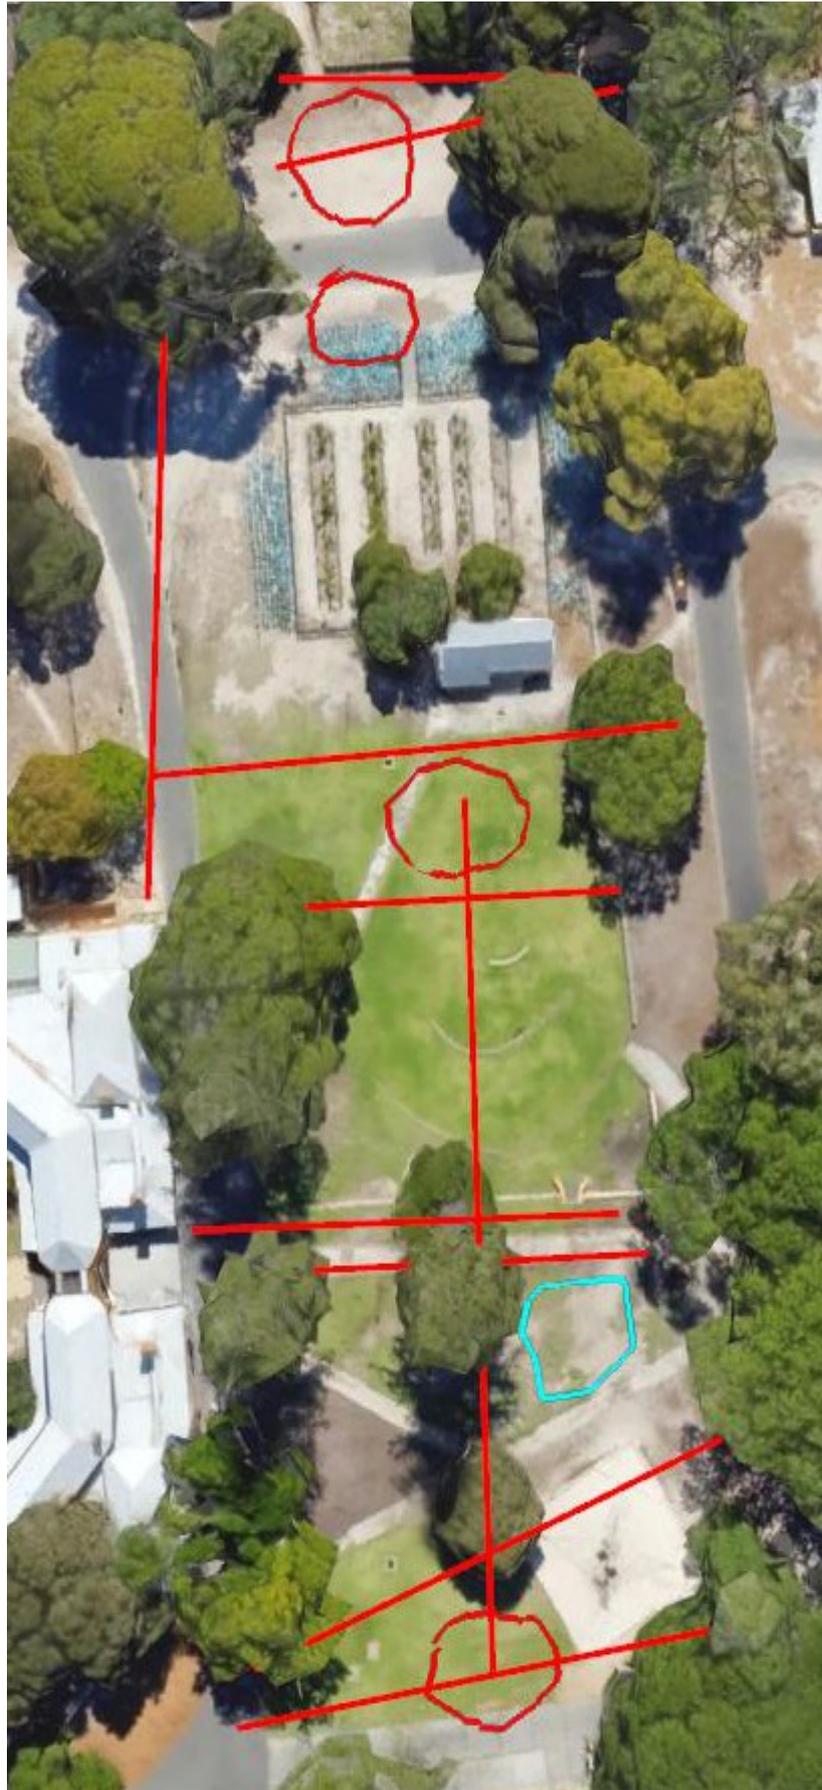
The survey area was dominated with surface and subsurface cultural objects that respond to the RADAR signal. 9 linear features and 5 roughly circular features were imaged within the survey area. These are shown on *figure 6*. The linear features are interpreted as subsurface drainage pipes and electrical wires. The red circular areas are interpreted as being associated with drainage and are most likely soakwells. The blue circular area is interpreted as drainage related due to the types of anomalies present.

No burial sites were imaged in the survey area. It must be remembered that due to the large amount of cultural material present, such a conclusion is never a certainty.

Figure 6 Final Interpretation map of Survey Area

A more accurate interpretation would be aided by any “as constructed plans” to further refine the conclusions.
