Programmed Facility Management

Annual Drinking Water Report

Rottnest Island Authority

July 2017 – June 2018

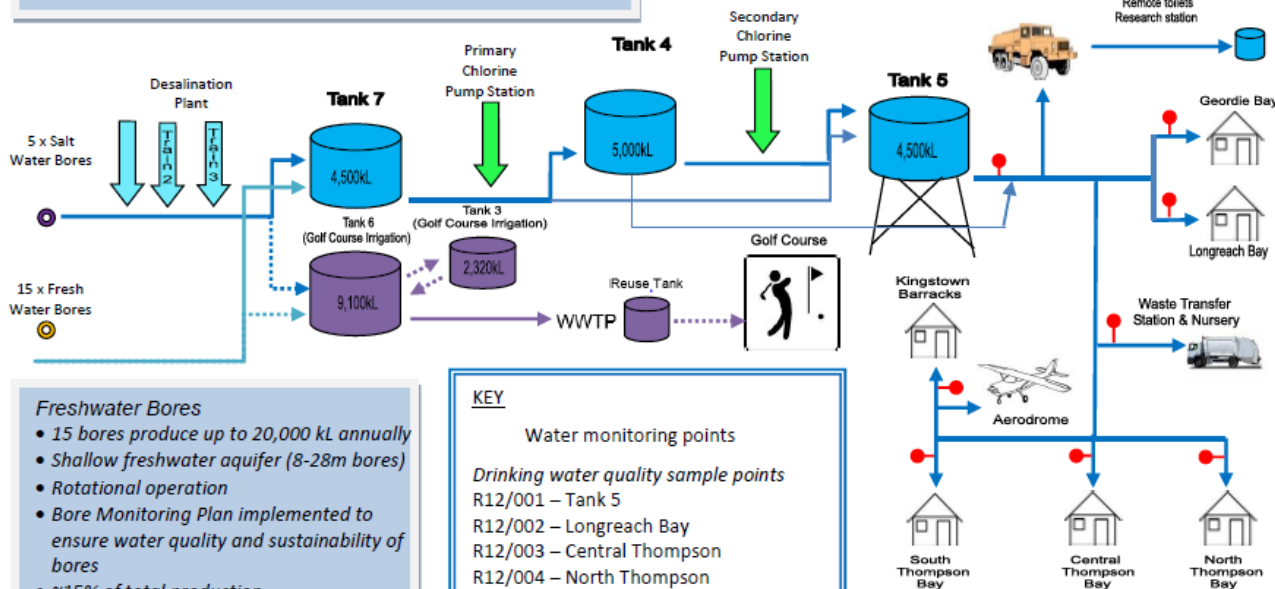
Figure 1 - Rottneest Island Water Distribution System

Freshwater Bores

- 15 bores produce up to 20,000 kL annually
- Shallow freshwater aquifer (8-28m bores)
- Rotational operation
- Bore Monitoring Plan implemented to ensure water quality and sustainability of bores
- ~15% of total production

Saltwater Beach Bores

- 5 beach bores
- Supply desalination plant
- ~85 % of total production

Treatment Systems

- Filtering of saltwater to remove particulate matter
- Reverse osmosis (RO) desalination plant
- Three RO trains can produce 273,000kL/annum (750kL/day)
- Calcite filter after RO plant

KEY

Water monitoring points

Drinking water quality sample points

- R12/001 – Tank 5
- R12/002 – Longreach Bay
- R12/003 – Central Thompson
- R12/004 – North Thompson
- R12/005 – South Thompson
- R12/006 – Kingstown Barracks
- R12/007 – Geordie Bay
- R12/008 – Nursery

Storage

- Combined total potable operational tank capacity is 14,000 kL
- Treated disinfected water is stored in Tank 5
- KPI to maintain 14 days storage
- Maximum resistance time to maintain residual chlorine level 4.5 days
- Winter actual resistance time 115 days
- Summer actual resistance time 38 days
- Tank 5 must be closely controlled to maintain residual chlorine levels
- Tanks 6 & 3 store irrigation water for golf course usage

Disinfection

- Chlorine gas is a primary & secondary disinfection
- Dose before & after tank 4

Distribution System

- Gravity fed from Tank 5
- Bulk cartage to Wadjemup lighthouse tank, remote toilets & UWA house.
- Waste transfer station & Nursery site used for rubbish truck wash down facility and irrigation, is now monitored
- Remote water tanks not suitable for drinking are signed accordingly
- Potential to bypass Tank 4
- Potential to feed gravity feed from tank 4

The drinking water quality characteristics are regularly monitored by the Programmed FM hydraulic technicians to ensure that drinking water produced on Rottnest Island meets the requirements of the Australian Drinking Water Guidelines. A schematical representation of the drinking water distribution system is provided in Figure 1.

The sampling locations are shown in Figure 1 – Diagram of Rottnest Island Water Distribution System.
