**Rottnest Island Authority**

**Annual Drinking Water Report**

***July 2019 – June 2020***

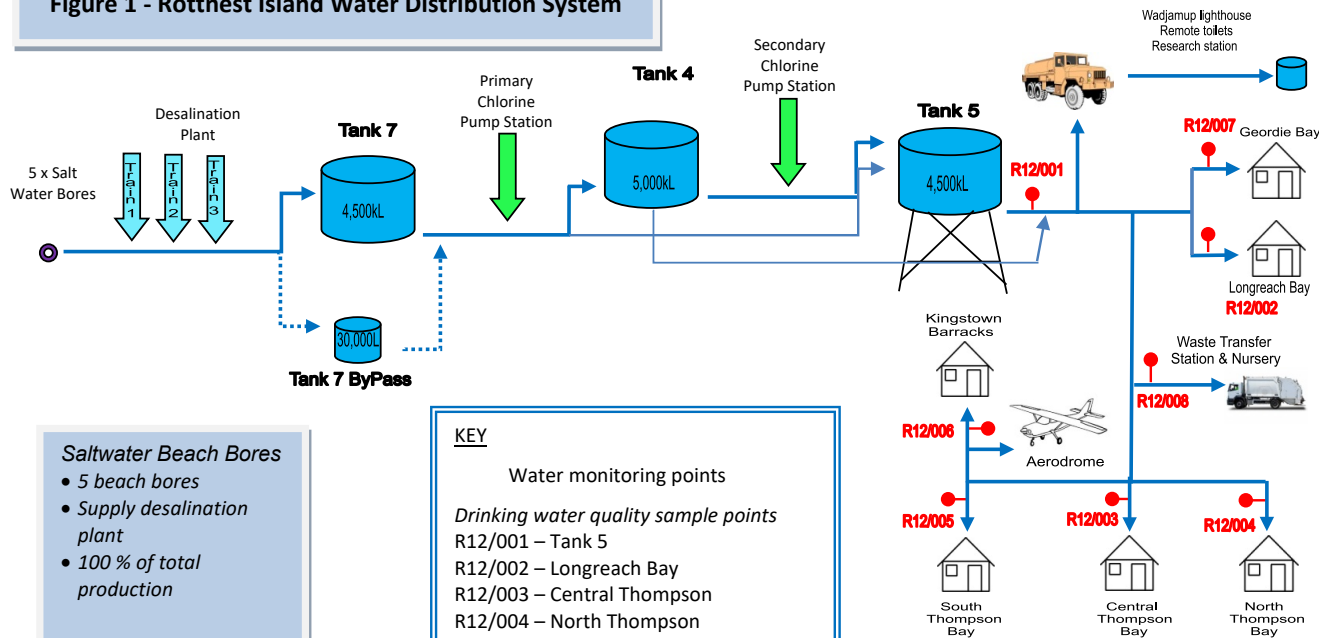
**Figure 1 - Rottnest Island Water Distribution System**

**Saltwater Beach Bores**

- 5 beach bores
- Supply desalination plant
- 100% of total production

**Treatment Systems**

- Filtering of saltwater to remove particulate matter
- Reverse osmosis (RO) desalination plant
- Three RO trains can produce 273,000kL/annum (750kL/day)
- Calcite filter after RO plant

**Disinfection**

- Chlorine gas is a primary & secondary disinfection
- Dose before & after tank 4

**Quality Issues**

- Saltwater bores subject to iron bacteria contamination
- Increased contact time with Chlorine can form Bromate

**Storage**

- Combined total potable operational tank capacity is 14,000 kL
- Treated disinfected water is stored in Tank 5
- Maintain 7 days storage
- Maximum resistance time to maintain residual chlorine level 4.5 days
- Winter actual resistance time 115 days
- Summer actual resistance time 38 days
- Tank 5 must be closely controlled to maintain residual chlorine levels

**Distribution System**

- Gravity fed from Tank 5
- Bulk cartage to Wadjemup lighthouse tank, remote toilets & UWA house.
- Waste transfer station & Nursery site used for rubbish truck wash down facility and irrigation, is now monitored
- Remote water tanks not suitable for drinking are signed accordingly
- Can bypass Tank 7 through Tank 7 Bypass.
- Potential to feed gravity feed from tank 4

The drinking water quality parameters are regularly monitored by the PFM Quality and Compliance Officer and hydraulic technicians to ensure that drinking water produced on Rottnest Island meets the requirements of the Australian Drinking Water Guidelines. A graphical representation of the drinking water distribution system is provided in Figure 1.

The sampling locations are shown in Figure 1 – Rottnest Island Water Distribution System and Figure 2 – Map of the Sampling Locations.

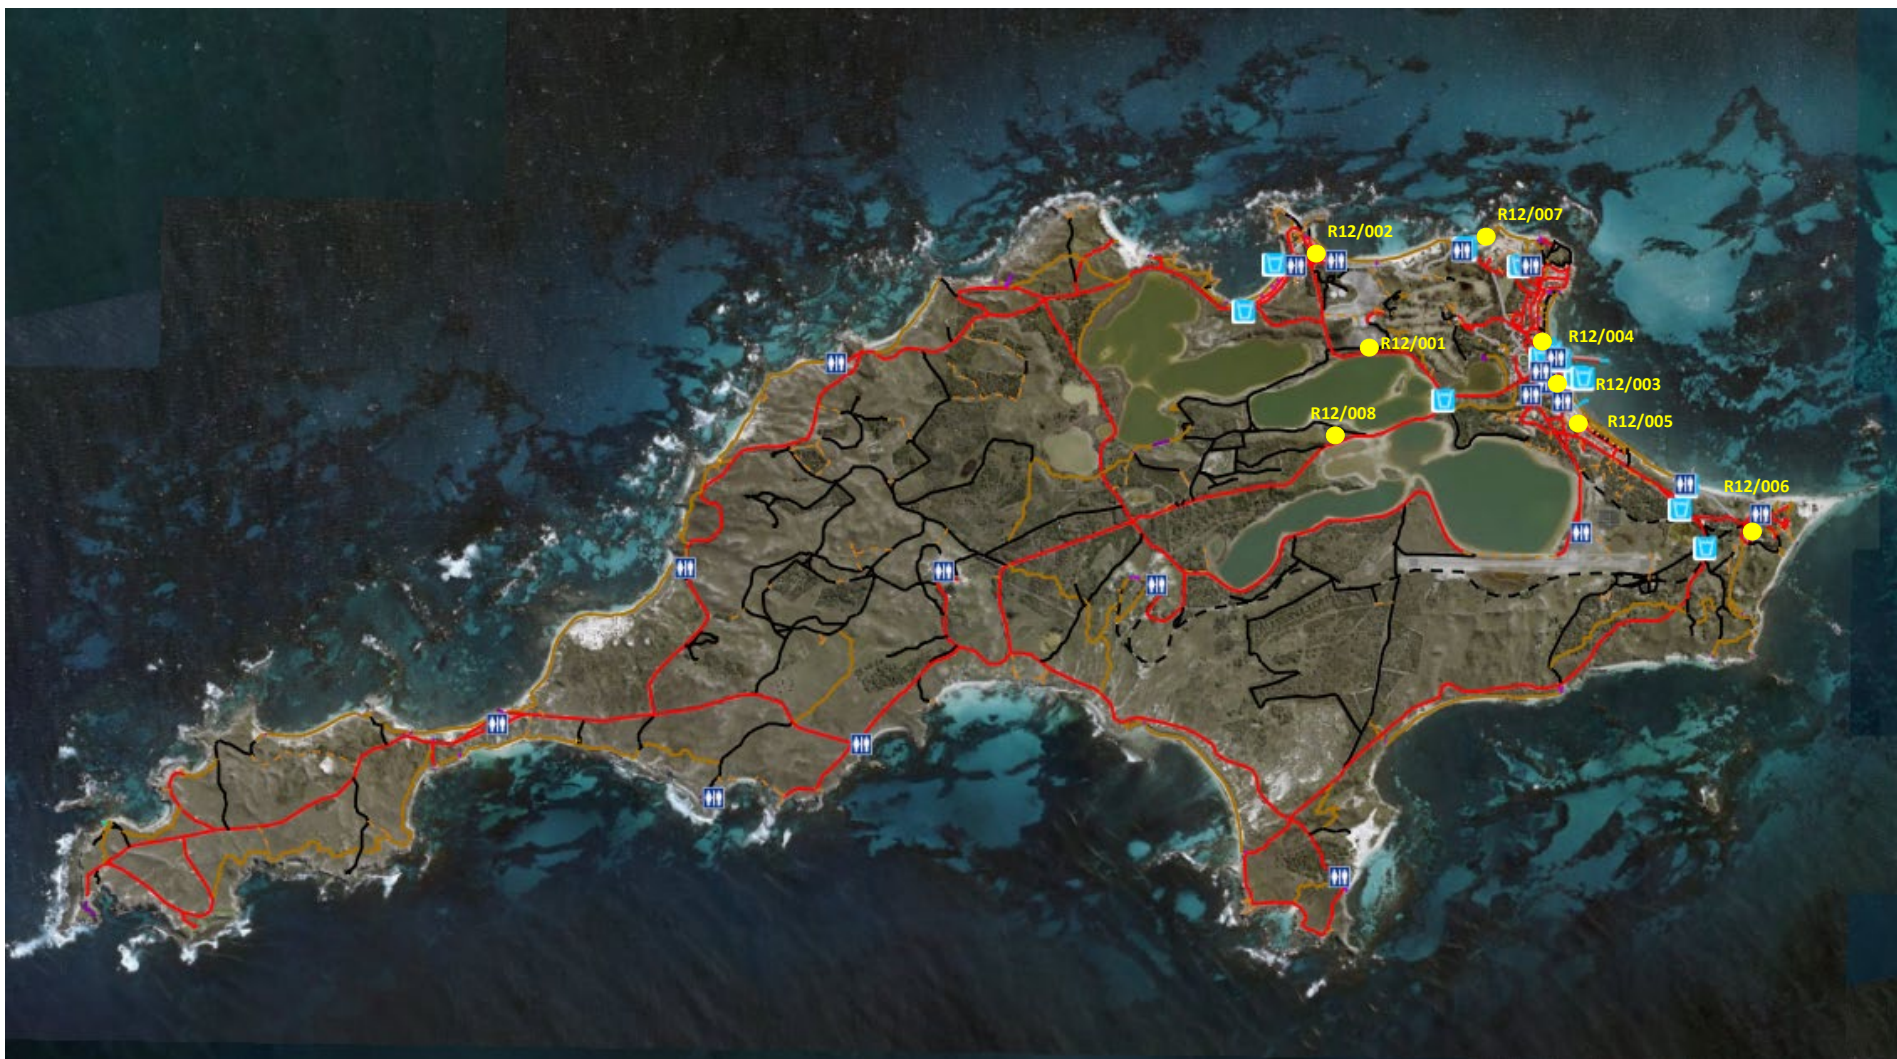
Figure 2 - Map of the Sampling Locations

- R12/001 – Tank 5
- R12/002 – Longreach Bay
- R12/003 – Central Thompson
- R12/004 – North Thompson
- R12/005 – South Thompson
- R12/006 – Kingstown Barracks
- R12/007 – Geordie Bay
- R12/008 – Nursery
