SOUTH WEST INDIGENOUS
SUPPORT SERVICES PTY LTD

Report of a Ground Penetrating
RADAR (GPR) survey of the proposed
Rottnest Lodge Redevelopment
Area, Wadjemup, Western Australia.

For Rottnest Island Authority

November 2019 | Dominic Howman, Dr Ian
Ryan and Tegan Raines

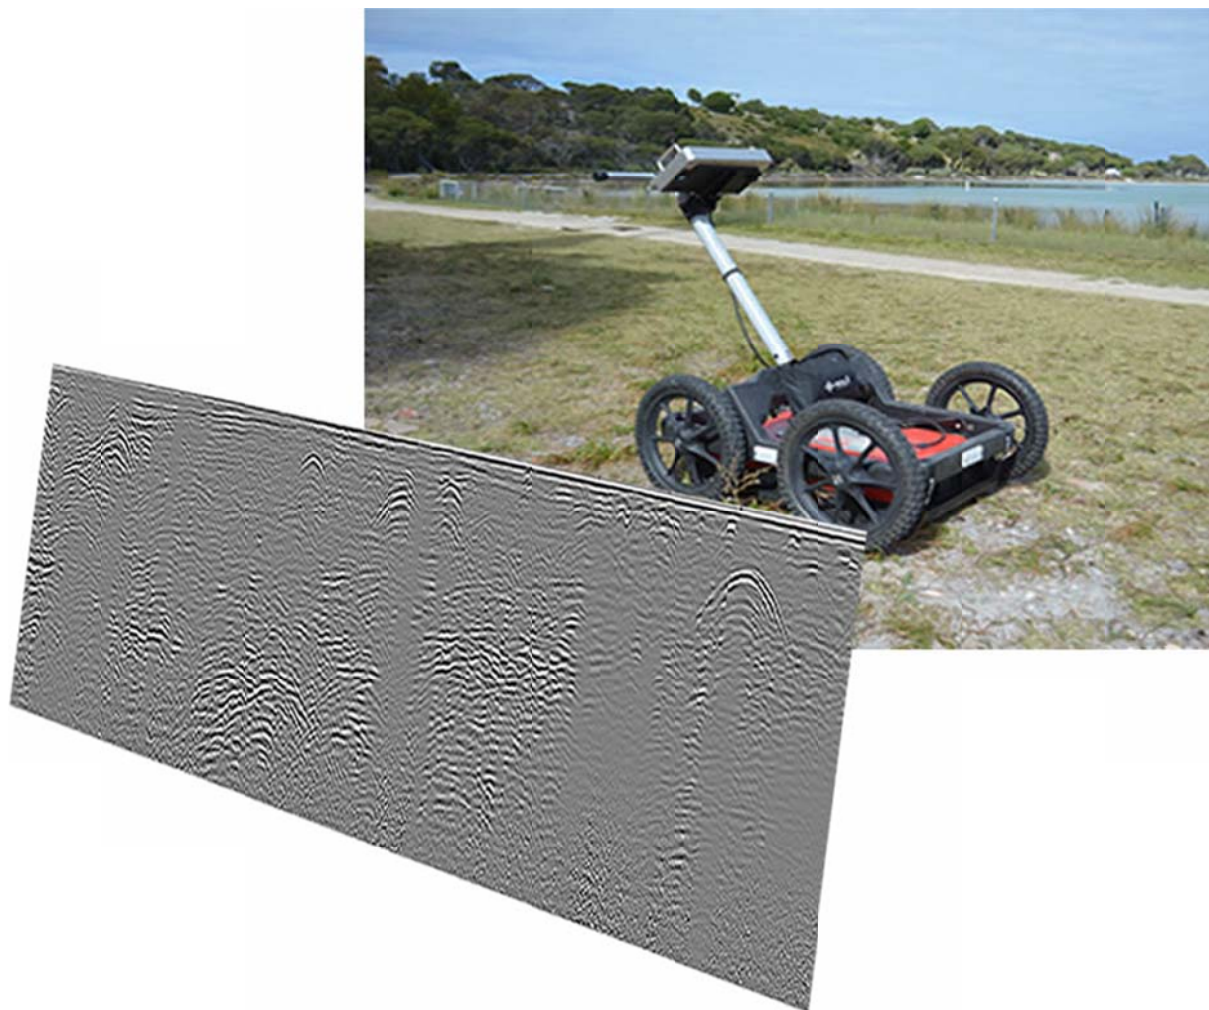
GPR is a geophysical method where radio waves are transmitted into the earth from a set of antennae and any reflected waves are recorded (see Figure 1). The radio waves are reflected back to the surface if the ground shows a change in the dielectric constant. Changes in dielectric constant are due to differences in the amount of air and water in the soil, or the presence of metallic objects.

Figure 1: SWISS_RIA_2019_2019_03 Rottnest Lodge GPR Assessment – GPR and resultant radiogram

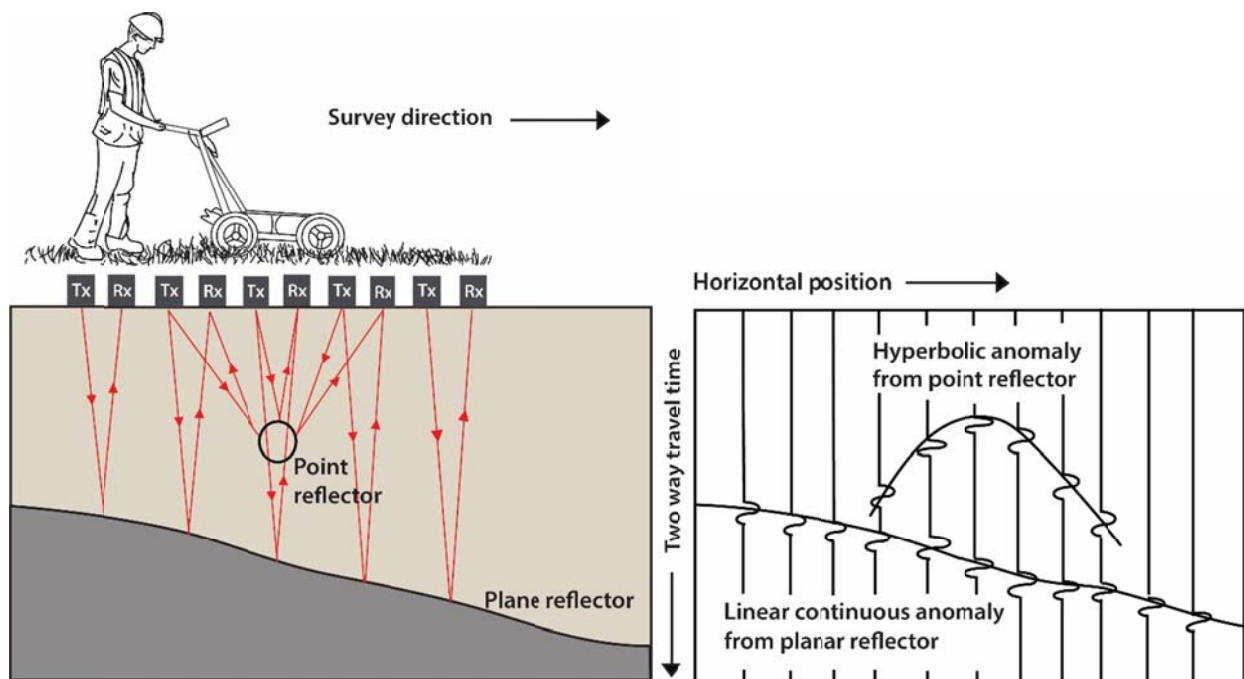
A radio wave emitted from the RADAR transmitter antennae will travel in the ground, and if reflected, return to the receiver antennae. The travel time of the returned reflection depends on the distance the object is from the RADAR antennae. Therefore, when the antennae are some distance from the reflecting object, the travel time is long and the reflection will be plotted as a deep feature in the radiogram (see Figure 2). As the antennae move closer to the object, the travel time becomes shorter. Eventually when the antennae are directly over the object, the travel time will be the shortest. A characteristic hyperbolic shape is seen in the radiogram as a result. As the antennae are moved away from the object, the second part of the hyperbole is plotted. Note that continuous layers are readily imaged.

Figure 2: SWISS_RIA_2019_2019_03 Rottnest Lodge GPR Assessment – Radiogram from point reflector (Image courtesy of Scantech Geoscience)

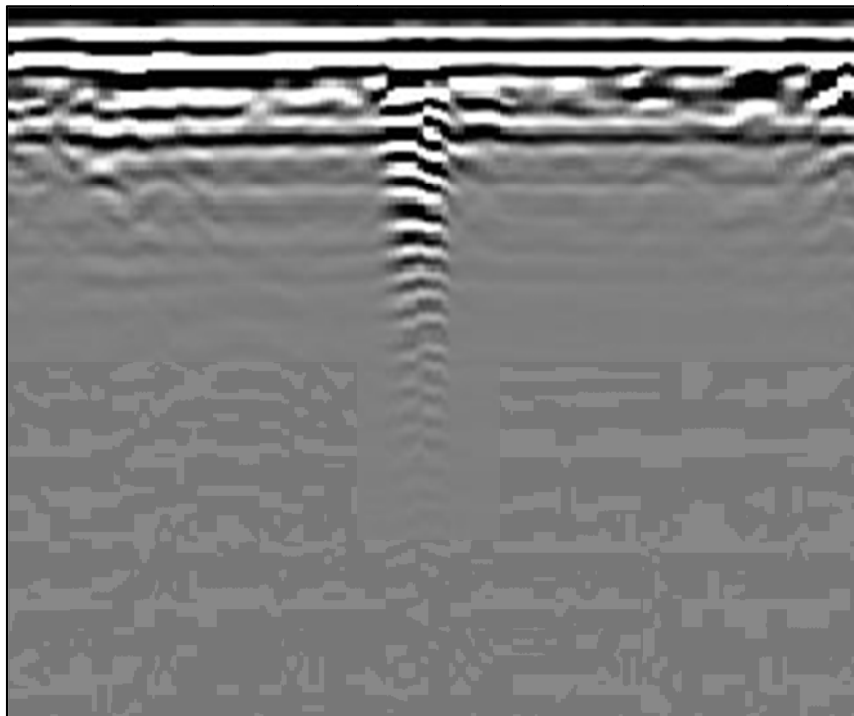
Due to the close proximity to buildings it was expected that the survey would locate pipes for water and drainage and electrical lines. Metallic pipes will give a characteristic ringing data and be a sharp anomaly over a short distance and are readily identified (see Figure 3). Discarded metallic objects on or in the near surface give similar responses.

Figure 3: SWISS_RIA_2019_2019_03 Rottnest Lodge GPR Assessment – Ringing Data over a metallic pipe

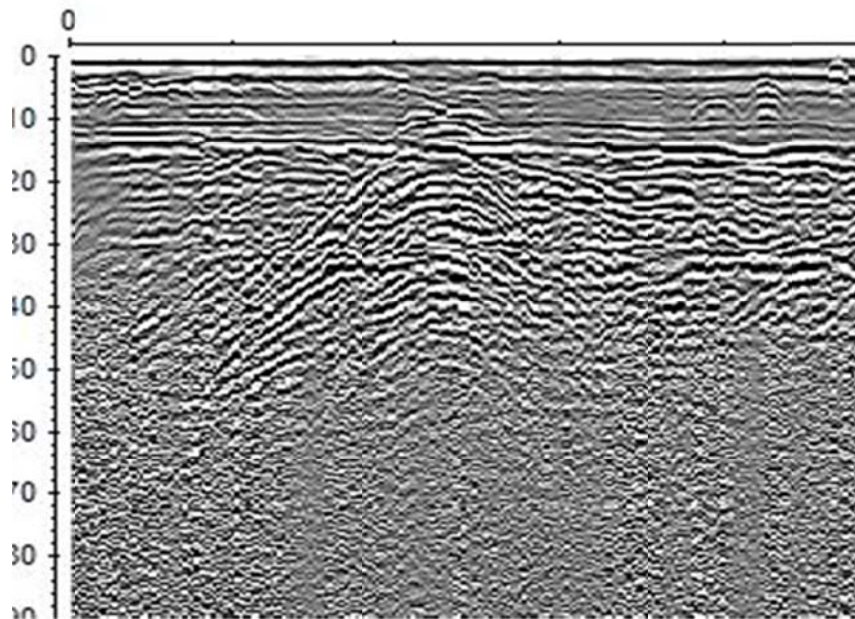
Larger drainage systems will show a response from the edges of the trench as well as the pipe/pipes installed (see Figure 4). Such anomalies can be recognised as drainage or other major services due to their extent and linear shape when tracked over several lines of data.

Figure 4: SWISS_RIA_2019_2019_03 Rottnest Lodge GPR Assessment – Response from larger drainage pipe/s

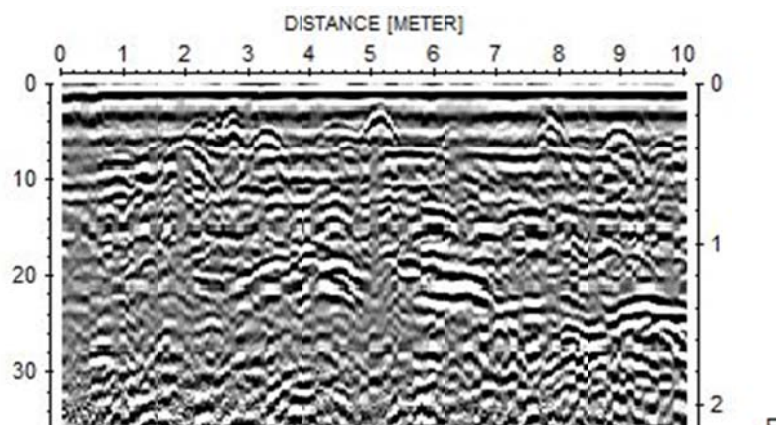
The large number of trees around the site meant that tree roots would be readily imaged due to their water content. Tree roots are best identified by their proximity to trees; however, the small size of the anomaly associated with tree roots is also characteristic (see Figure 5).

Figure 5: SWISS_RIA_2019_2019_03 Rottnest Lodge GPR Assessment – Tree roots at surface down to 400mm (scale to the right is depth in metres)

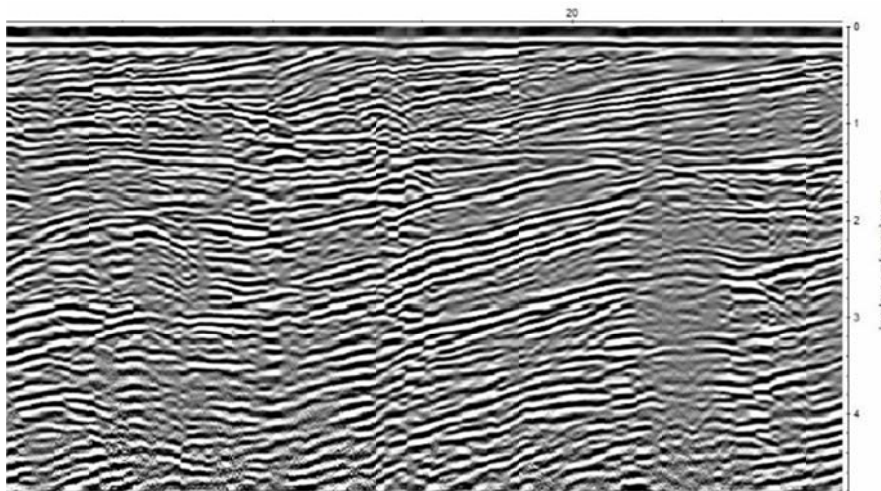
Limestone is formed by a bedding process where layers of sand are cemented in place. Limestone will show obvious bedding planes that can change direction depending on conditions when the sand is deposited (see Figure 6). Fractures in the limestone are common and can be seen as breaks in the layering.

Figure 6: SWISS_RIA_2019_2019_03 Rottnest Lodge GPR Assessment – RADAR response to limestone showing bedding and fracturing

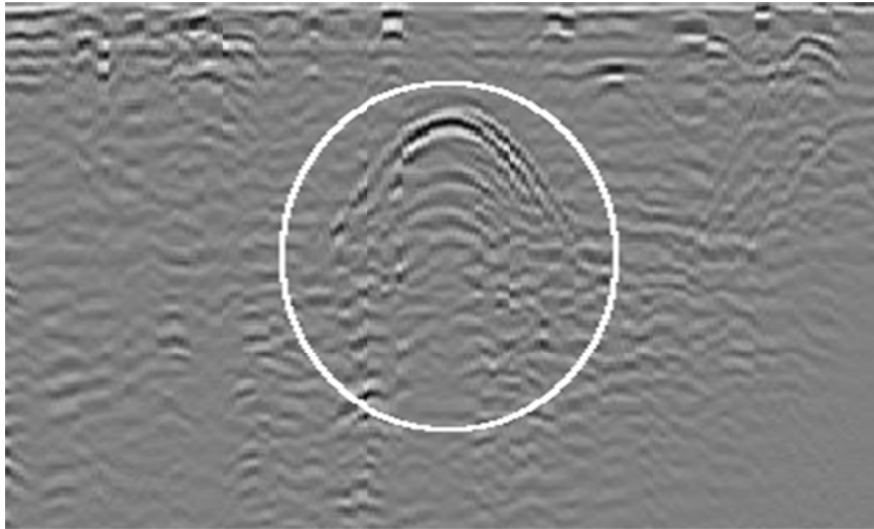
Figure 7: SWISS_RIA_2019_2019_03 Rottnest Lodge GPR Assessment – Response from Pioneer burial showing a series of hyperbola

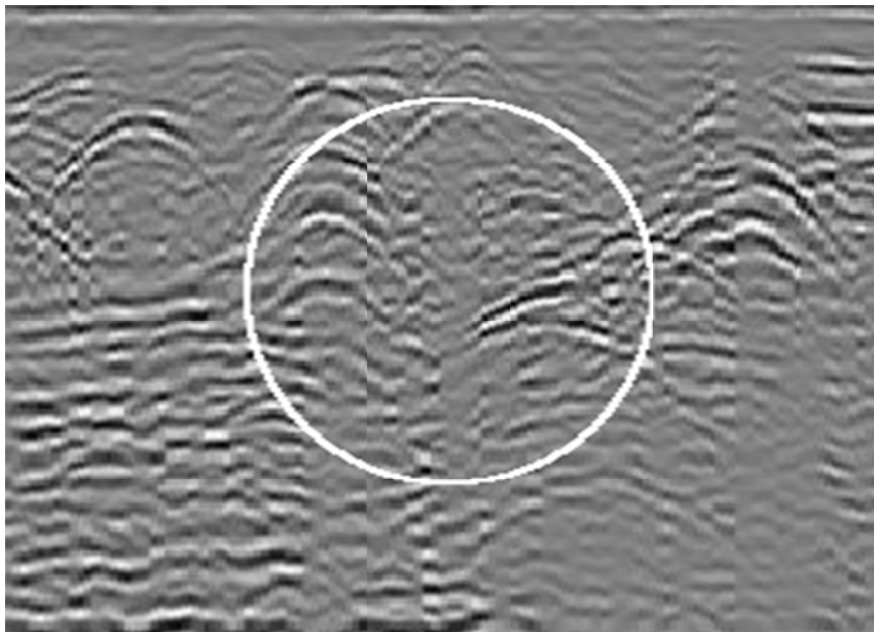
The second type of burial in the pioneer cemetery shows much clearer evidence of trenching (see Figure 8). Hyperbola flank either side of the burial and little evidence of a response from the coffin is present.

Figure 8: SWISS_RIA_2019_2019_03 Rottnest Lodge GPR Assessment – Response from Pioneer burial showing obvious trenching

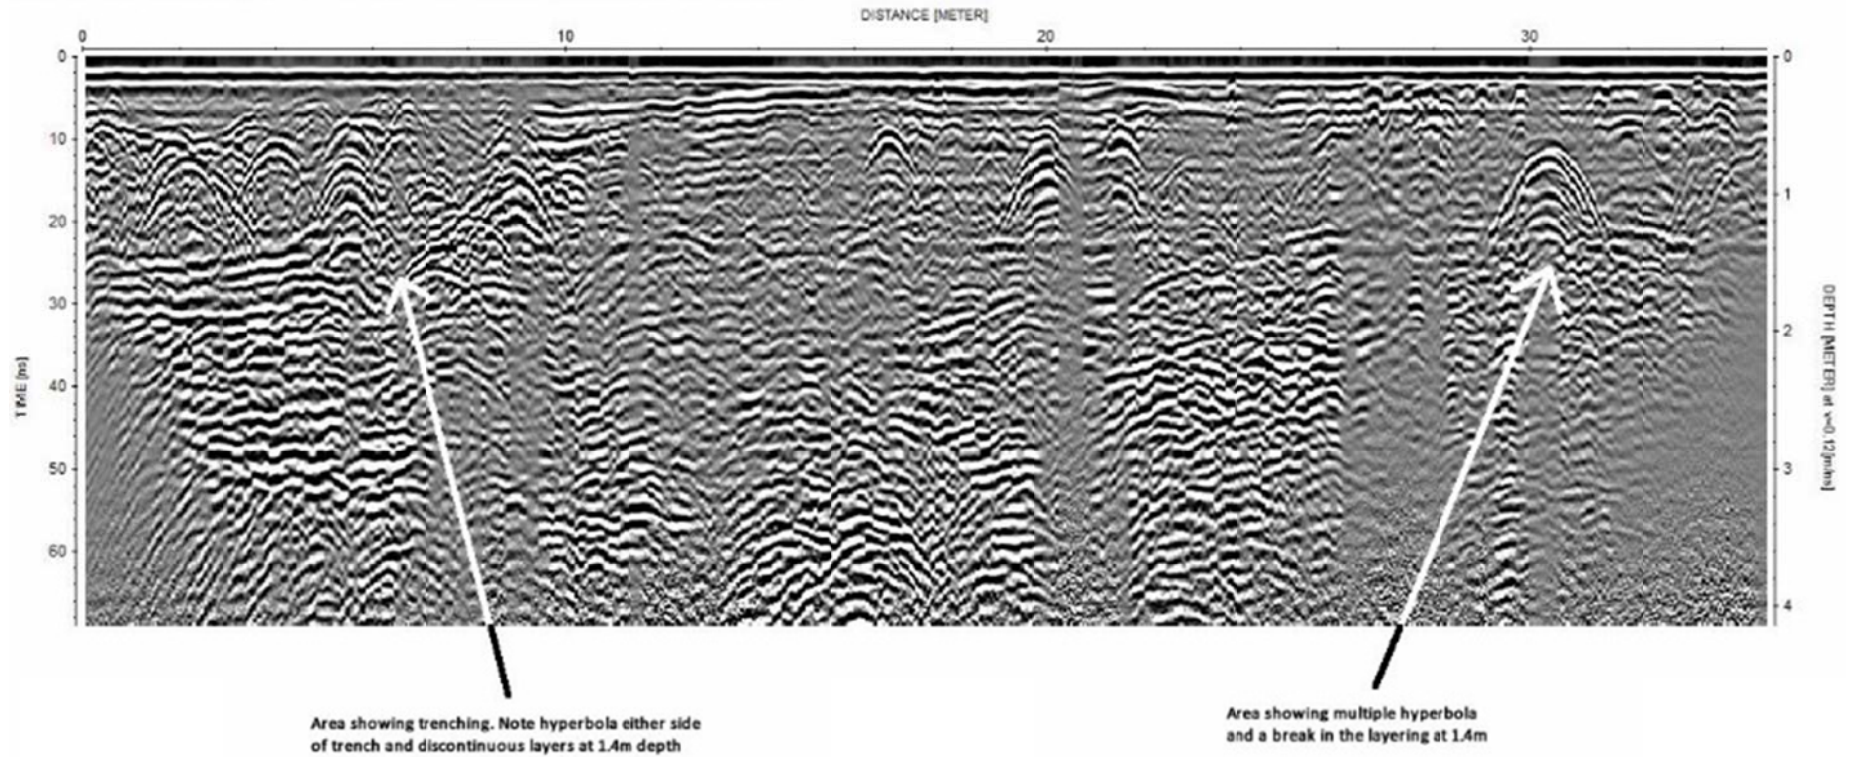
Several lines of data were acquired over the Wadjemup Aboriginal Prisoners Cemetery in order to find possible responses from burials. A prospective line is shown in Figure 9. Due to the fact that only a few profiles were collected, anomalies could be potentially from services as much as they could be from burials. However, the type of anomalies measured agree with the type of anomaly seen in the pioneer cemetery. The depths of the anomalies are also consistent with burial practices of the time.

Figure 9: SWISS_RIA_2019_2019_03 Rottnest Lodge GPR Assessment – Line of data from Wadjemup Cemetery

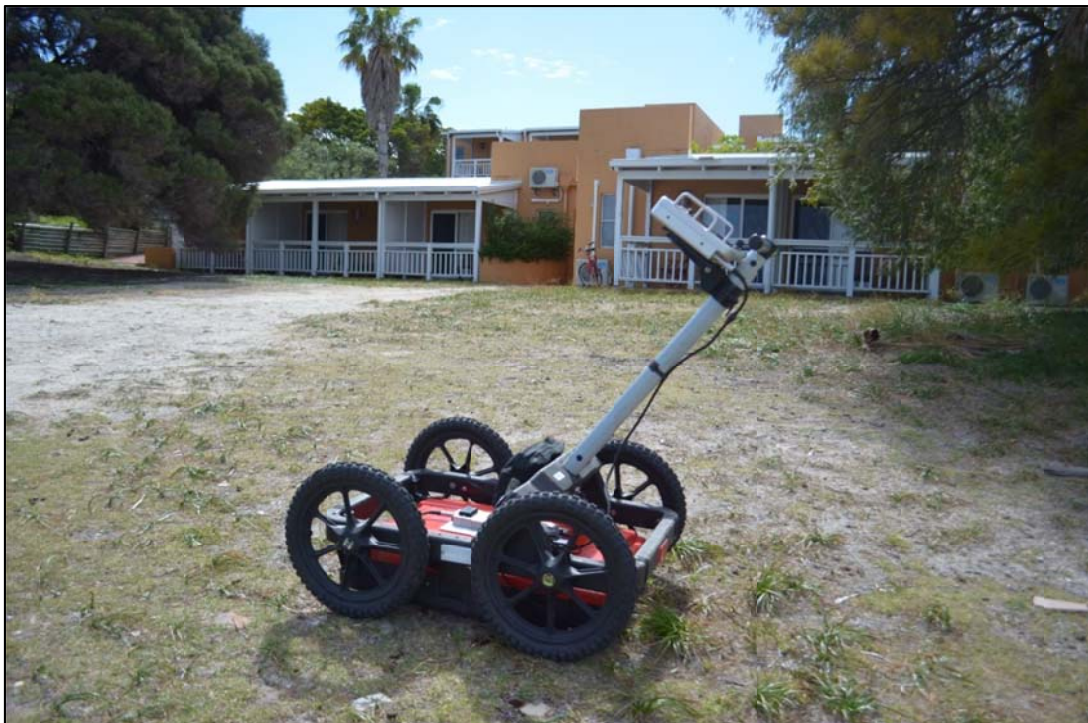
- a second low frequency antenna that collects data simultaneously with the high frequency antenna;
- an inbuilt GPS receiver so position can be logged; and
- an encoder on the cart wheel for accurate linear distance measurement.

Plate 1: SWISS_RIA_2019_2019_03 Rottnest Lodge GPR Assessment – MALA Easylocator Pro Widerange RADAR

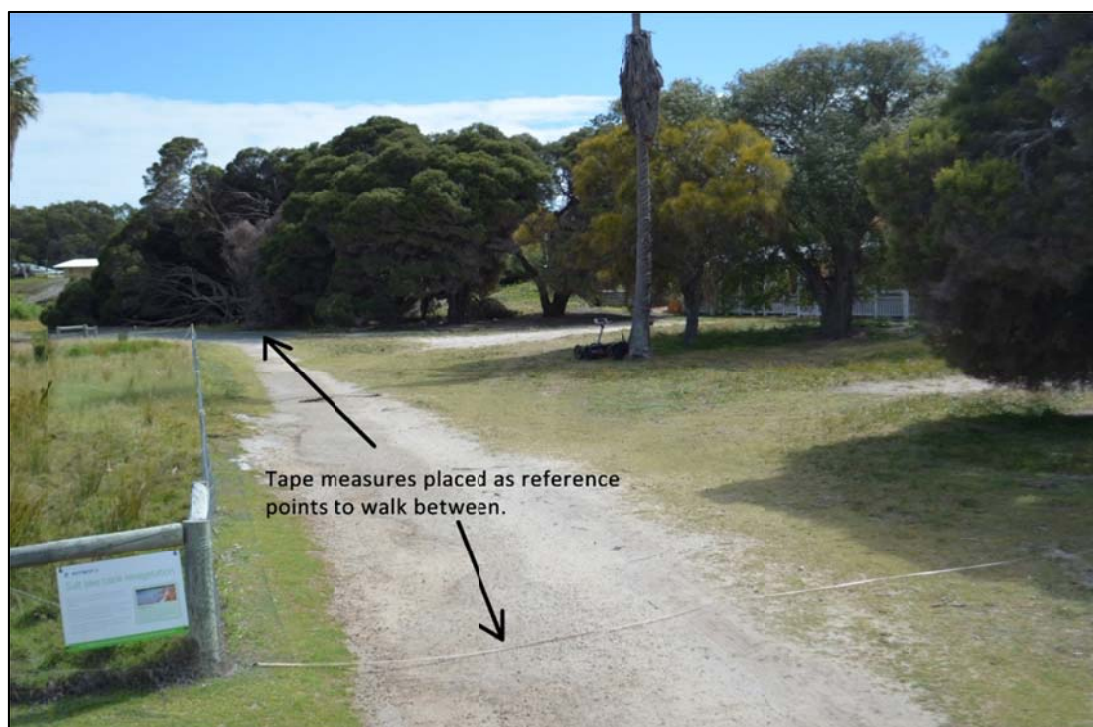
RADAR data must be collected in a grid pattern in order to differentiate linear features such as pipes etc from more discrete anomalies. The line spacing of the grid is chosen to ensure proper coverage of the ground depending on the type of object you are detecting. When surveying for burials, a line spacing of 0.5 m is appropriate. To ensure consistency of spacing of grid lines, tape measures were placed on the ground as a reference points (see Plate 2). A pink pin flag was used at each end as a visual guide.

Plate 2: SWISS_RIA_2019_2019_03 Rottnest Lodge GPR Assessment – Garden Lake showing tape measures for line spacing control

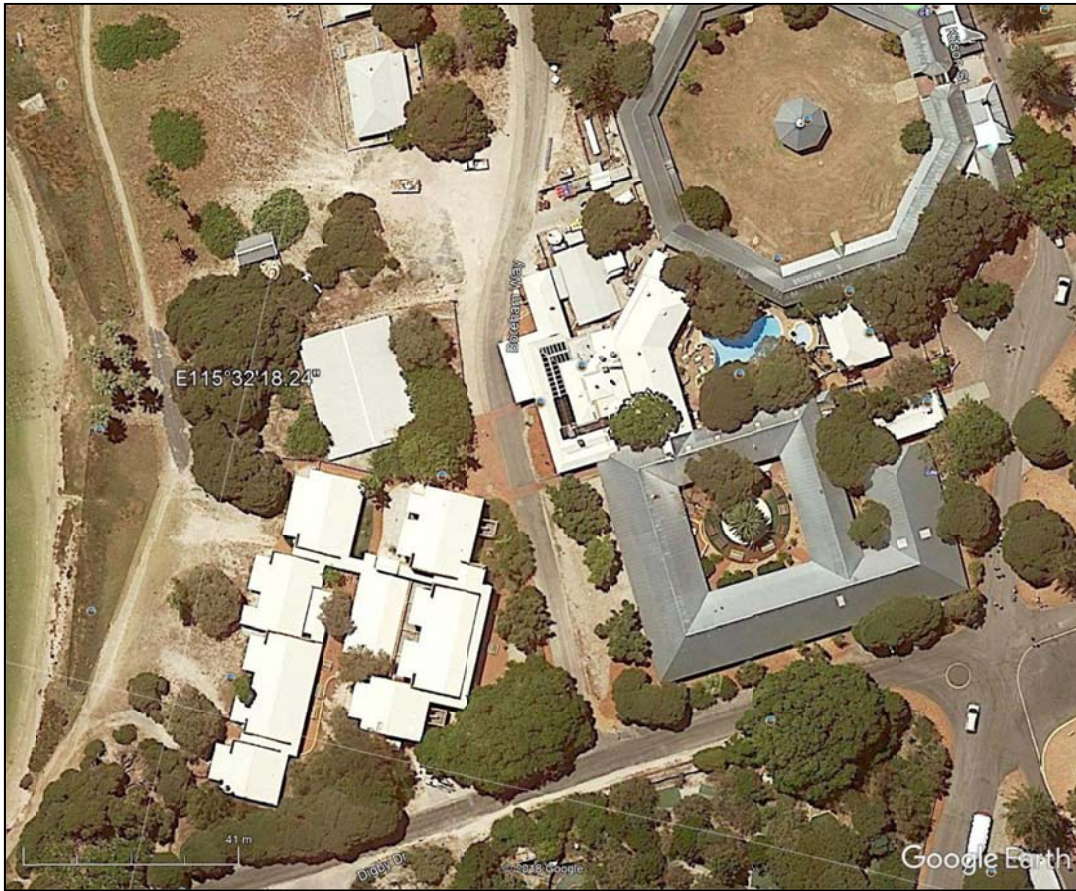
The Survey Area was divided into 13 areas that could be surveyed using grids of parallel lines (see Plate 3). Where a tree was encountered that couldn't be gone around, the RADAR was stopped, moved to the other side of the tree and a new line continued from that position. This was a particular problem in the Southern area of the site.

Plate 3: SWISS_RIA_2019_2019_03 Rottnest Lodge GPR Assessment - aerial photograph showing survey area

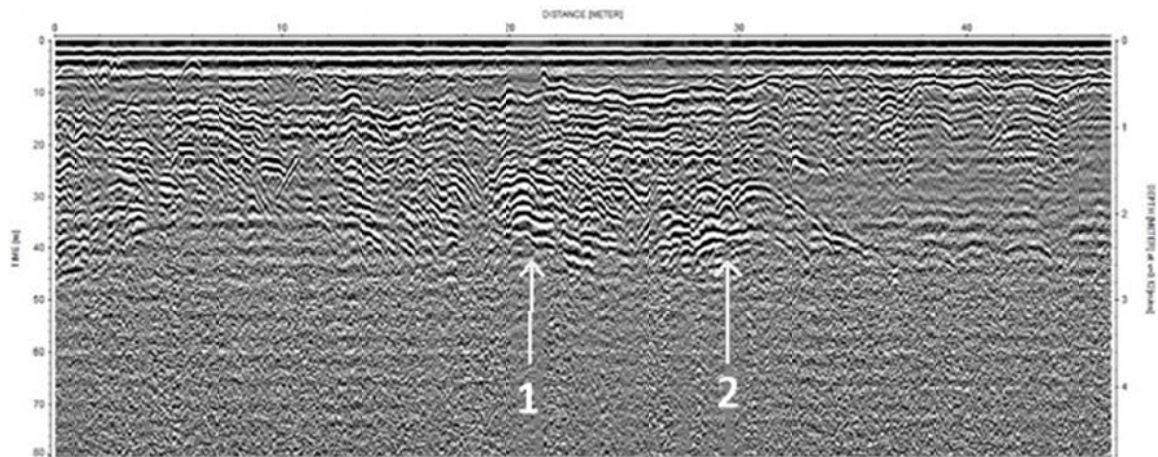
Figure 12 shows the line of data with anomalies 1 and 2. Both anomalies are just over 1.5 m deep. Anomaly 2 shows signs of trenching.

Figure 12: SWISS_RIA_2019_2019_03 Rottnest Lodge GPR Assessment – Area 1, Anomalies 1 and 2

6. advised that no ground disturbing activities below a depth of 30 cm should take place within 2.5 m of anomalies 1-5 in Area 1;
7. advised that no ground disturbing activities below a depth of 30 cm should take place within 2.5 m of the anomalies grouped together as anomaly 6 and anomaly 7 in Area 2;

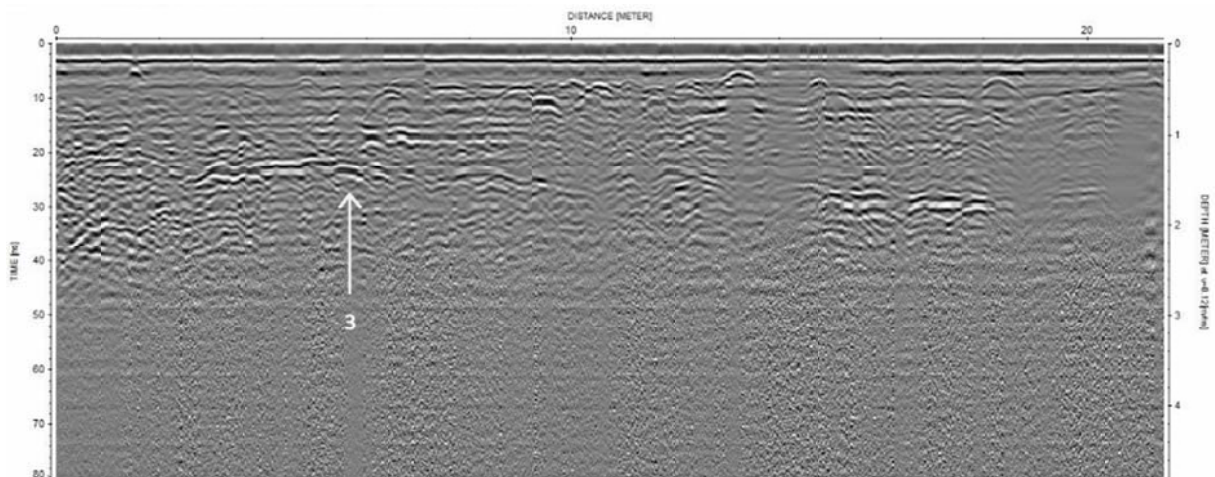
Figure 13 shows the line of data with anomaly 3. A disruption of the layers above the anomaly is evident.

Figure 13: SWISS_RIA_2019_2019_03 Rottnest Lodge GPR Assessment – Area 1, Anomaly 3

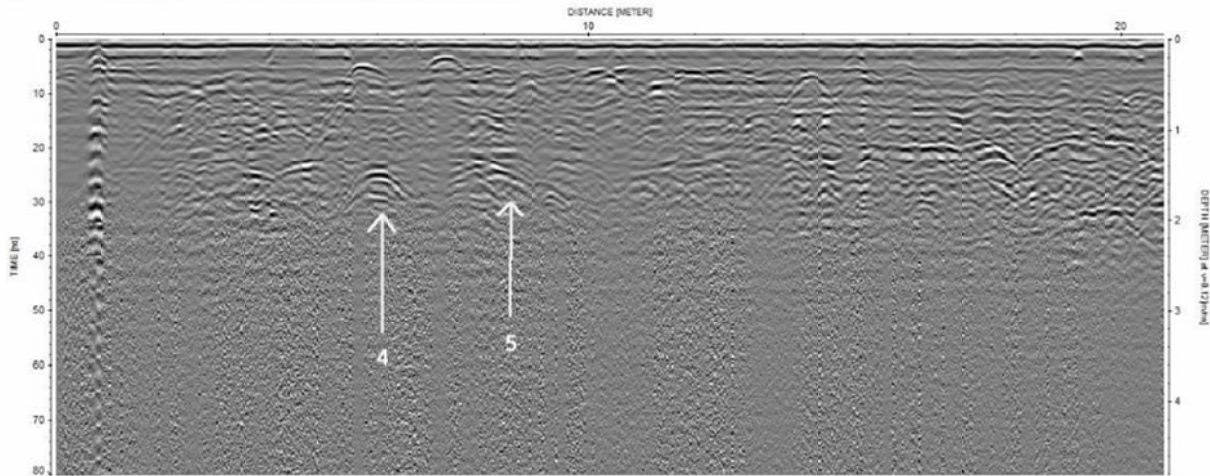
Figure 14 shows the line of data with anomalies 4 and 5. Anomaly 4 shows a response from the top and bottom of the object.

Figure 14: SWISS_RIA_2019_2019_03 Rottnest Lodge GPR Assessment – Area 1, Anomalies 4 and 5

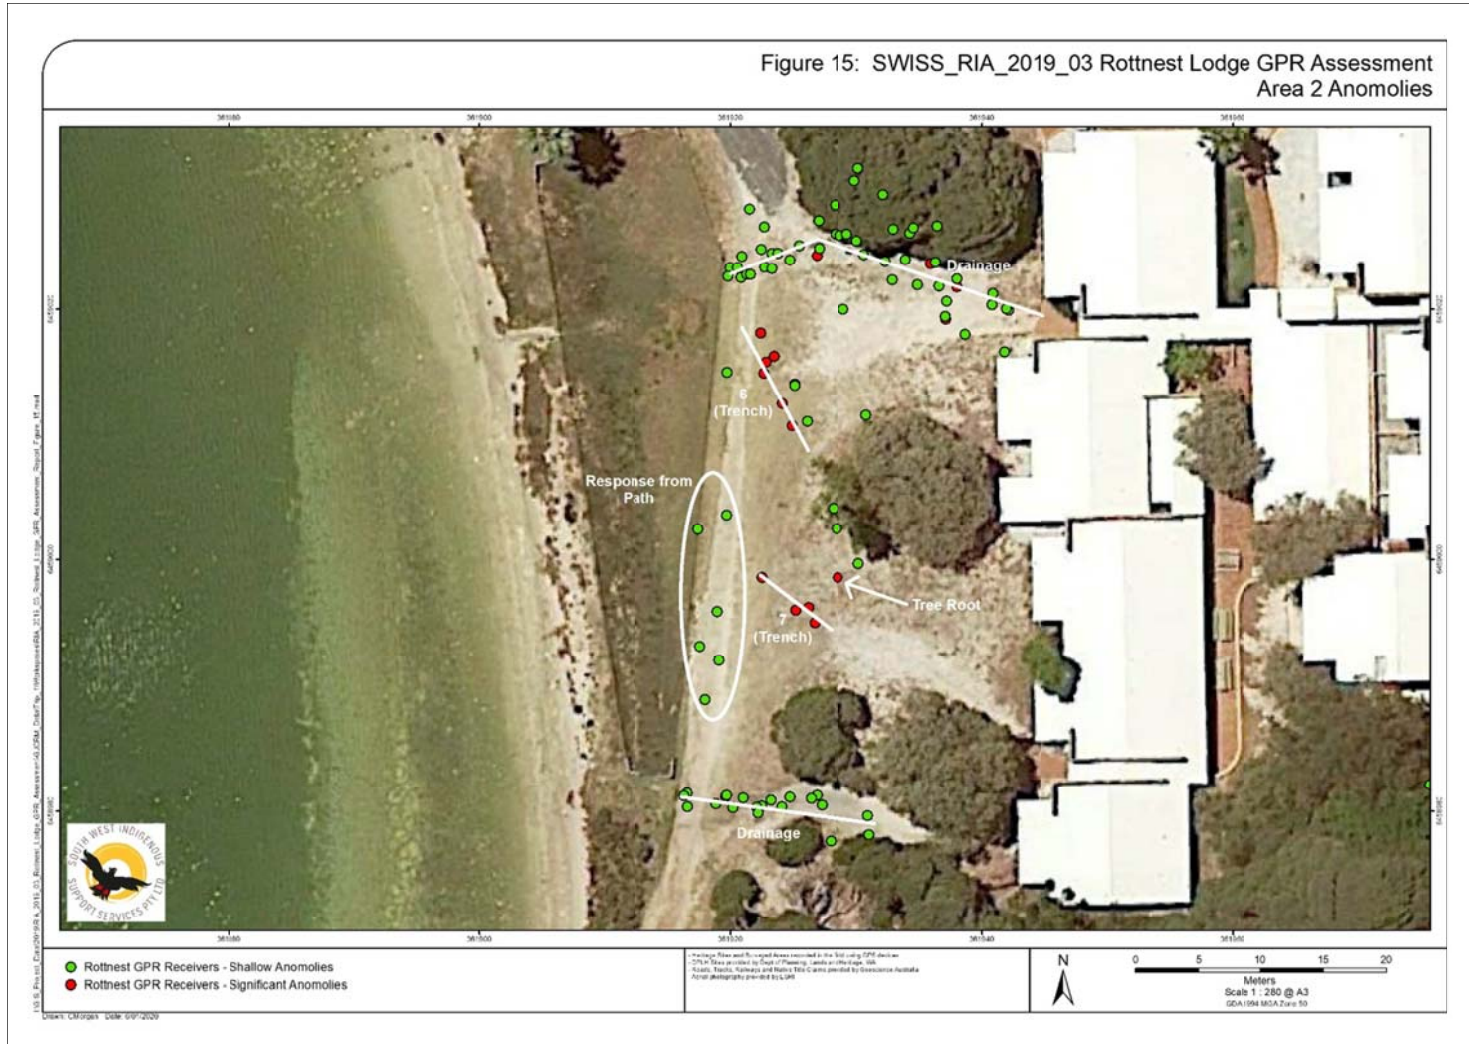
Area 2 is the South West corner of the survey area. It consists of an open area adjacent to Garden Lake and a heavily wooded area to the South of that (see Figure 15). Very little response was obtained from under the wooded section and the results from this section has been omitted from the analysis.

Figure 15: SWISS_RIA_2019_2019_03 Rottnest Lodge GPR Assessment – Area 2, showing interpreted anomalies. Green circles indicate shallow anomalies and red circles indicate significant anomalies between 1 m and 2 m

9. advised that any ground disturbing activities below a depth of 30 cm between 2.5 and 10 m of the anomalies grouped together as anomaly 6 and anomaly 7 in Area 2 be undertaken with extreme caution;

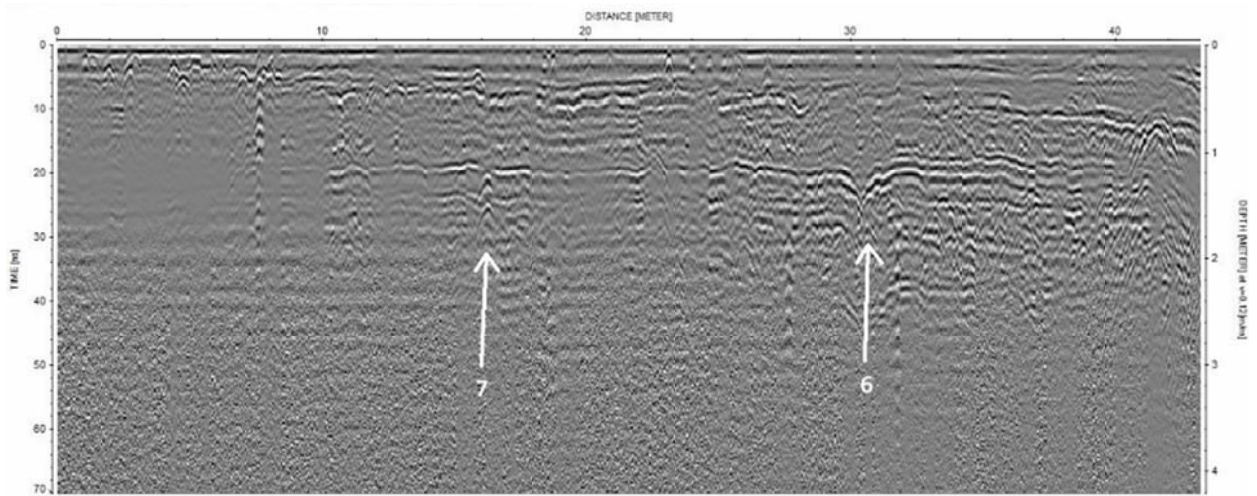
Figure 16: SWISS_RIA_2019_2019_03 Rottnest Lodge GPR Assessment – Area 2, Anomalies 6 and 7

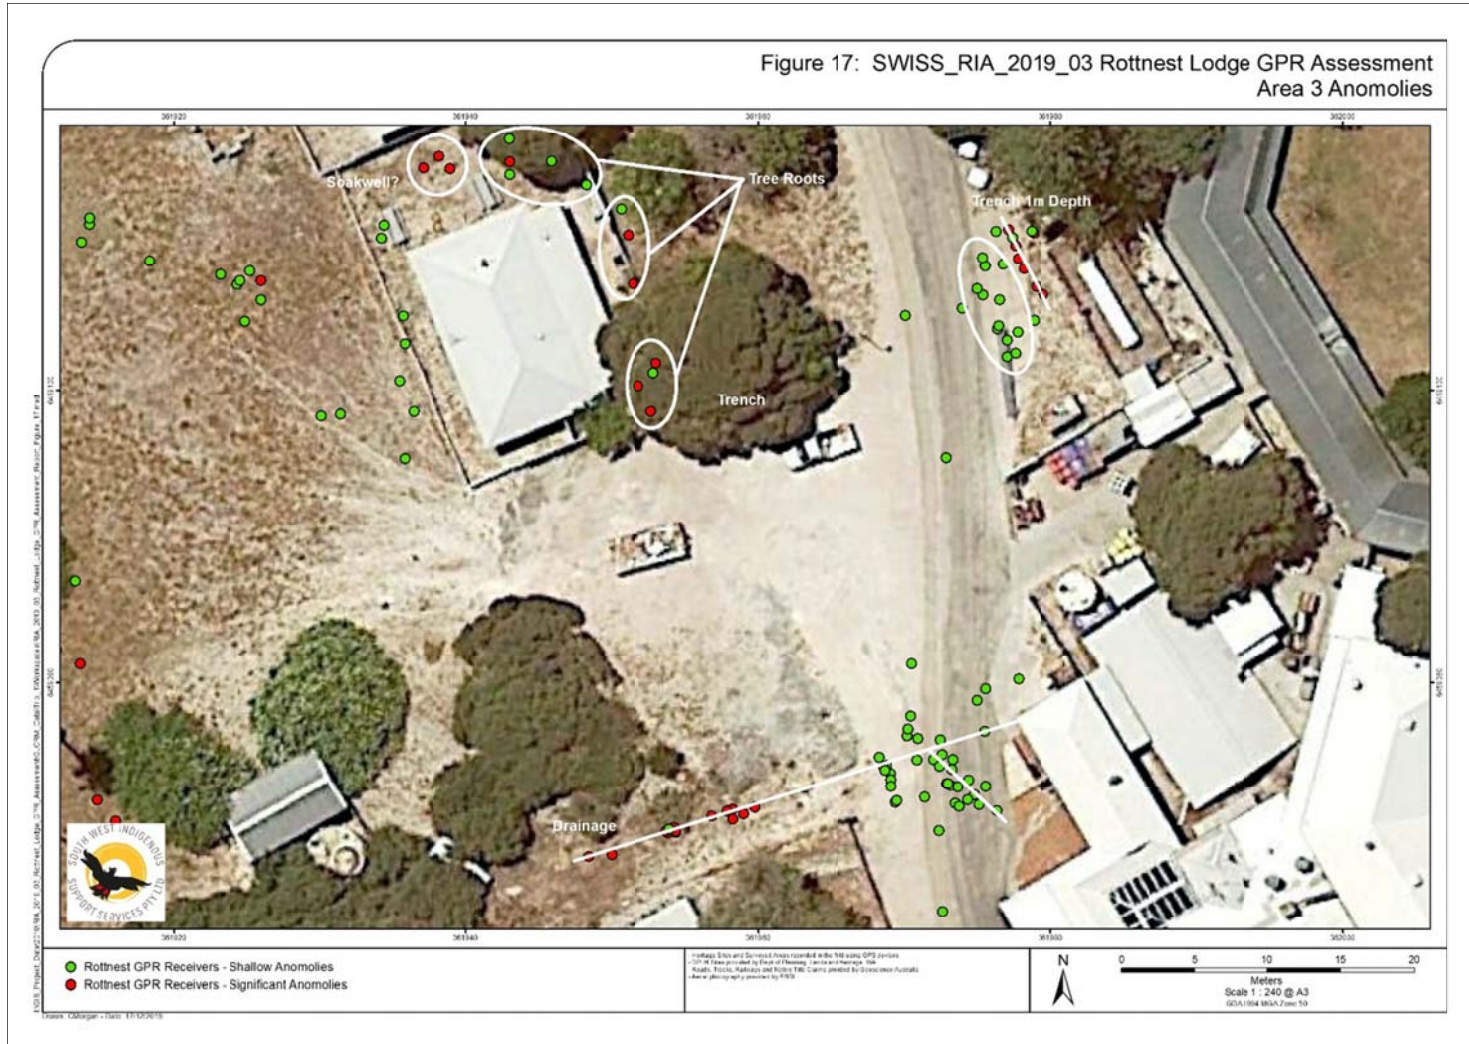
Area 3 is adjacent to the Quod in the north part of the site. It is raised up above the shore of Garden Lake on a limestone outcrop (see Figure 17). A series of deep anomalies, 1 m depth, extend roughly North South adjacent to the wall of the Quod. The depth indicates it might be some sort of drainage or other subsurface infrastructure. Several shallow anomalies run parallel to the road in this same area (Figure 17). This is interpreted to be an extension of the excavations associated with the 1 m deep trench. The shape of the anomalies suggests pipes and thus could be associated with drainage.

Figure 17: SWISS_RIA_2019_2019_03 Rottnest Lodge GPR Assessment – Area 3, showing Interpreted Anomalies. Green circles indicate shallow anomalies and red circles indicate significant anomalies between 1 m and 2 m

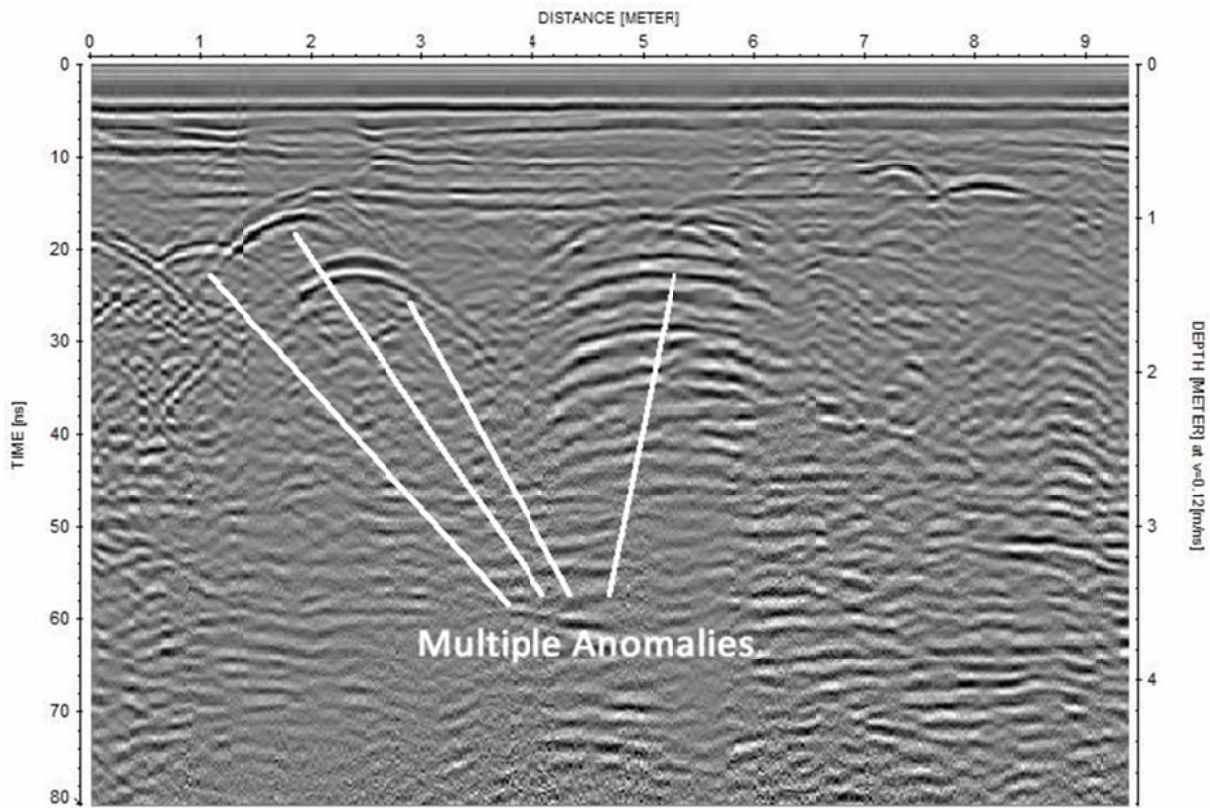
Figure 18: SWISS_RIA_2019_2019_03 Rottnest Lodge GPR Assessment – Area 3, Multiple Anomalies between the Road and Quod

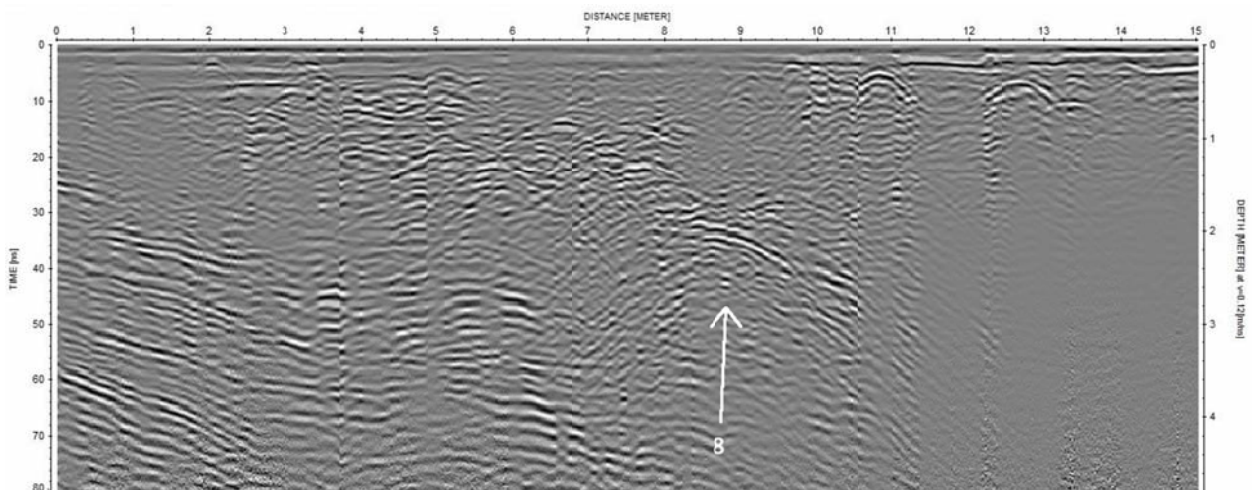
A few deeper anomalies were found in the house at the north west corner of Area 3. Most are interpreted as tree roots; however, three anomalies stand out in the centre of the backyard (labelled Anomaly 8). These have been interpreted as a possible soak well (Figure 18).

Figure 19: SWISS_RIA_2019_2019_03 Rottnest Lodge GPR Assessment – Area 3, Anomaly 8, Interpreted to be a possible soakwell

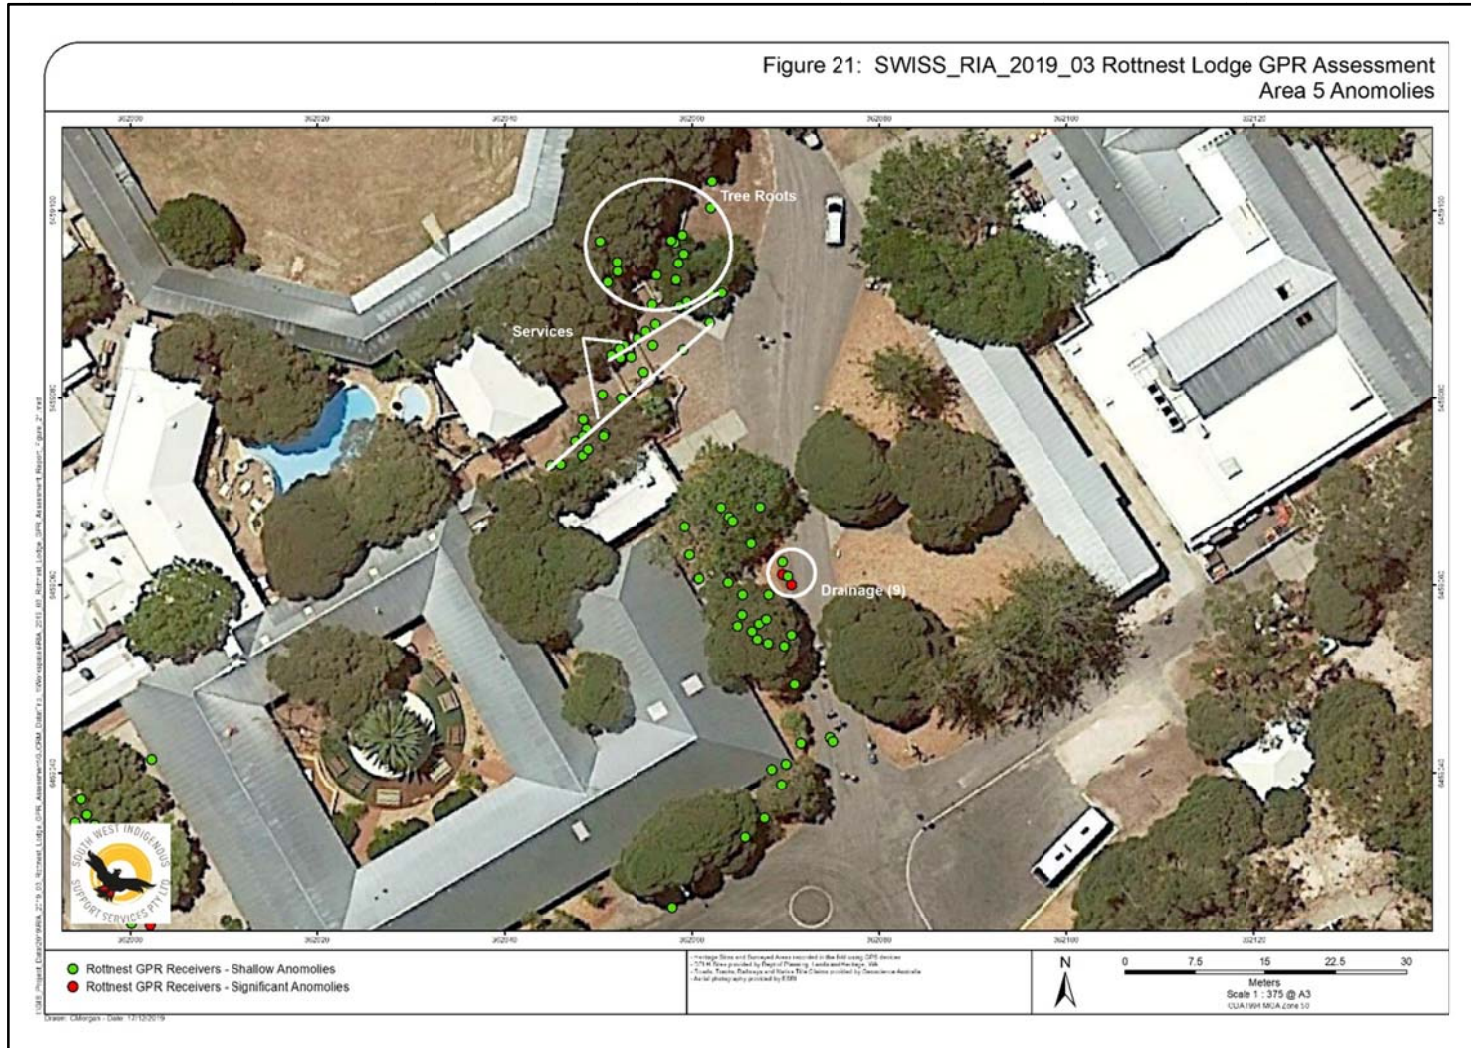
Figure 21: SWISS_RIA_2019_2019_03 Rottnest Lodge GPR Assessment – Area 5, Showing Interpreted Anomalies. Green circles indicate shallow anomalies and red circles indicate significant anomalies between 1 m and 2 m

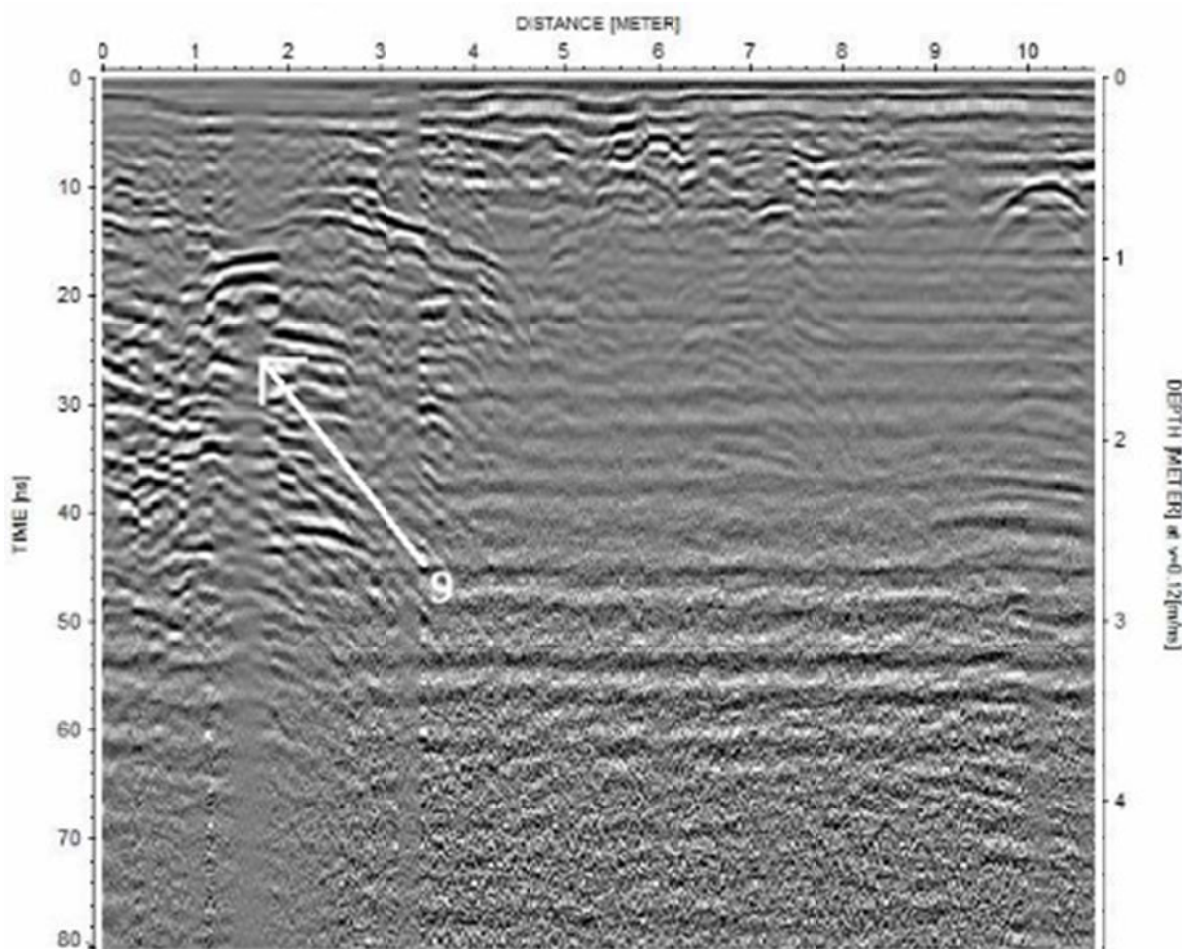
The area in front and to the side of the Boys Reformatory shows many anomalies due to tree roots. There is a deeper anomaly interpreted as drainage near the road (see Figure 22). The depth is just over 1 m and shows a tabular shape.

Figure 22: SWISS_RIA_2019_2019_03 Rottnest Lodge GPR Assessment – Area 5, Anomaly 9 near road interpreted as drainage or a soak well
